**Complaint – Instrument Cluster Temporarily Black: Re-Programming Instrument Cluster Control Unit (89/21)**

Model Line: **Taycan (Y1A)**

Model Year: **As of 2020**

Concerns: **Instrument cluster control unit**

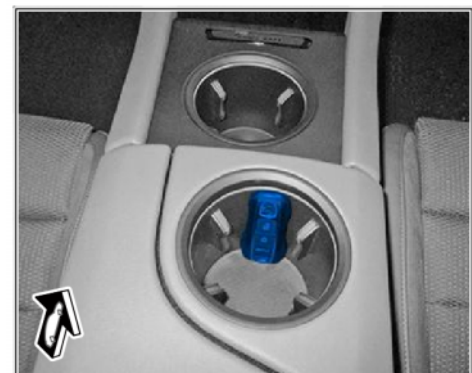
*Emergency start tray*

- Work Procedure: 1 Place the driver's key with the back facing down into the front left storage compartment in the center console (emergency start tray) to guarantee a continuous radio link between the vehicle and the driver's key ⇒ *Emergency start tray*.
- 2 Carry out general preliminary work for control unit programming as described in ⇒ *Workshop Manual '9X00IN Basic instructions and procedure for control unit programming - section on "Preliminary work"*.
