# TIB 43-069: DPF Regeneration Two-Position Switch Parameter Update

43-069

DPF Regeneration Two-Position Switch Parameter Update

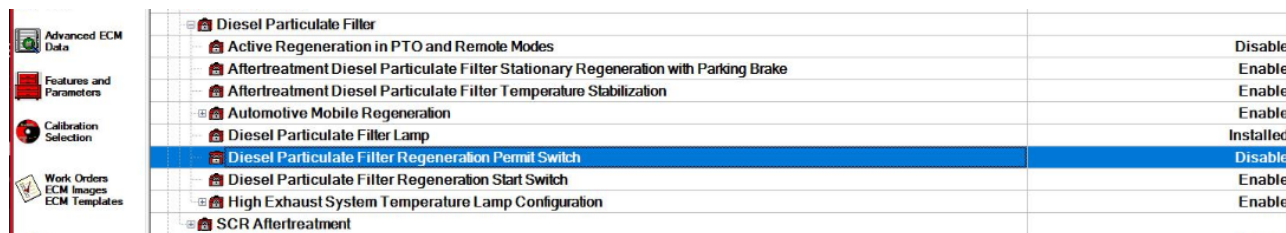
A DPF regeneration two-position switch parameter is causing inhibited DPF regeneration. A parameter update, via Cummins Insite, restores proper DPF regeneration function.

1. Connect to the truck with Cummins Insite.
2. Select **Features and Parameters** and locate the parameter named *Diesel Particulate Filter Regeneration Permit Switch*.

3. Set the status to **Disable**.
