Service Alert

Subject: CONNECTED VEHICLE REMOTE FUNCTIONS INOPERATIVE AND/OR ENGINE NO START DUE TO LOW BATTERY VOLTAGE	Service Alert No.: SA-045/21
	Last Issued : 08/02/2021

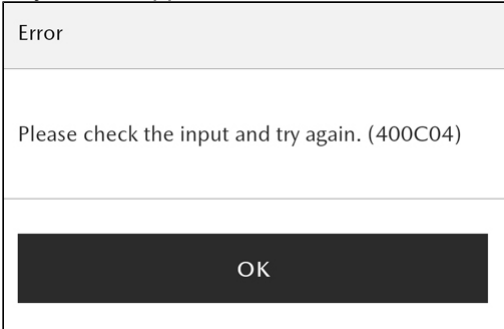
Connected Vehicle Remote function(s) inoperative. <ul style="list-style-type: none">• Engine Start / Stop• Door Lock / Unlock• Lights ON / OFF	The MyMazda App will show remote function error

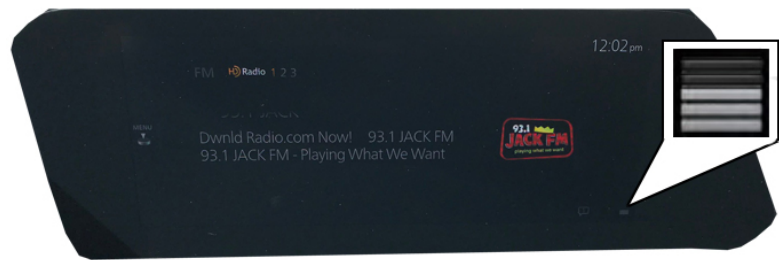
- Connected Vehicle reception strength icon shows normal.
- CV Viewer shows normal customer enrollment information.
