Service Alert

Mazda North American Operations
Irvine, CA 92618-2922

Subject: CONNECTED VEHICLE REMOTE FUNCTIONS INOPERATIVE, NO OTP AND/OR ENGINE NO START DUE TO LOW BATTERY VOLTAGE	Service Alert No.: SA-045/21
	Last Issued : 08/02/2021

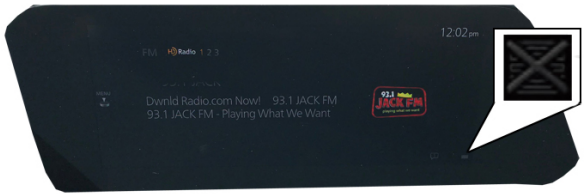
<p>CX-5 and CX-9 - If enrolled, CV Viewer shows normal customer enrollment information.</p>
