# Service Alert

<b>Subject:</b> <b>CONNECTED VEHICLE REMOTE FUNCTIONS INOPERATIVE, NO OTP AND/OR ENGINE NO START DUE TO LOW BATTERY VOLTAGE</b>	<b>Service Alert No.: SA-045/21</b>
	<b>Last Issued : 08/05/2021</b>

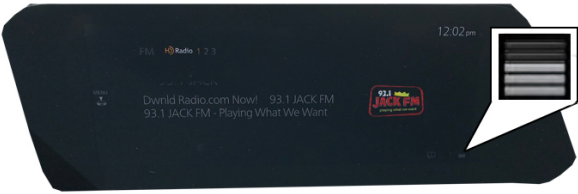
<div style="border: 1px solid black; padding: 5px;"> <p>Error</p> <hr/> <p>Please check the input and try again. (400C04)</p> <hr/> <div style="background-color: black; color: white; text-align: center; padding: 5px; width: fit-content; margin: 0 auto;">OK</div> </div>	
<p>Connected Vehicle reception strength icon</p>	<p>CX-5 CX-9</p>

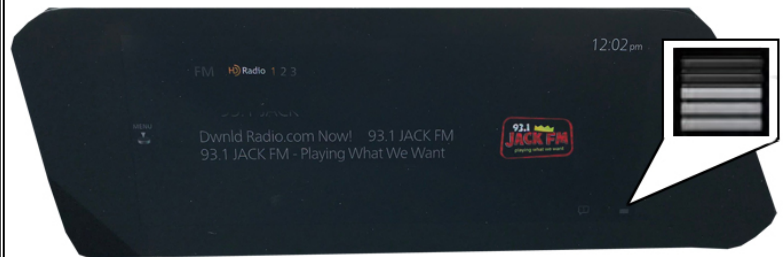
23. Verify repair.	Customer is <b>enrolled</b> into connected vehicle services. (CX-5 and CX-9 only)	At vehicle pickup, use the customer's phone and the MyMazda App to confirm connected vehicle remote functions operate normally. <ul style="list-style-type: none"> <li>• Engine Start / Stop</li> <li>• Door Lock / Unlock</li> <li>• Lights ON / OFF</li> </ul>
	Customer is <b>not enrolled</b>	Confirm connected vehicle reception strength icon shows good

into  
connected vehicle  
services.

strength.
