Service Alert

Subject:	
MAZDA CONNECT CLOCK SHOWS INCORRECT TIME	Service Alert No.: SA-046/21
	Last Issued : 08/10/2021

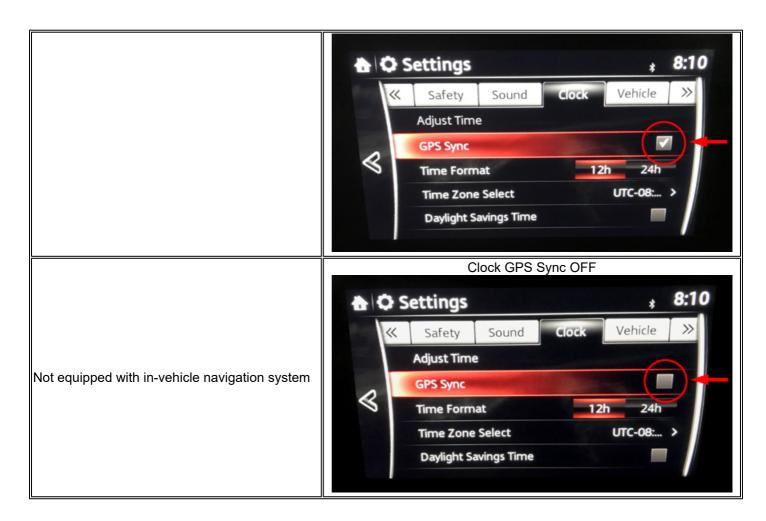
Some customers may complain about incorrect MAZDA CONNECT clock time. This may be caused by an incorrect clock GPS Sync setting.

Clock accuracy can be improved using the following settings:

Vehicle	Setting
Equipped with in-vehicle navigation system	Clock GPS Sync ON

Note: If clock GPS Sync is ON and vehicle is started with no view of the sky, clock may be inaccurate momentarily.
