Articles Contained in this Issue

02 2019 and up 2.4L Turbo, P0299

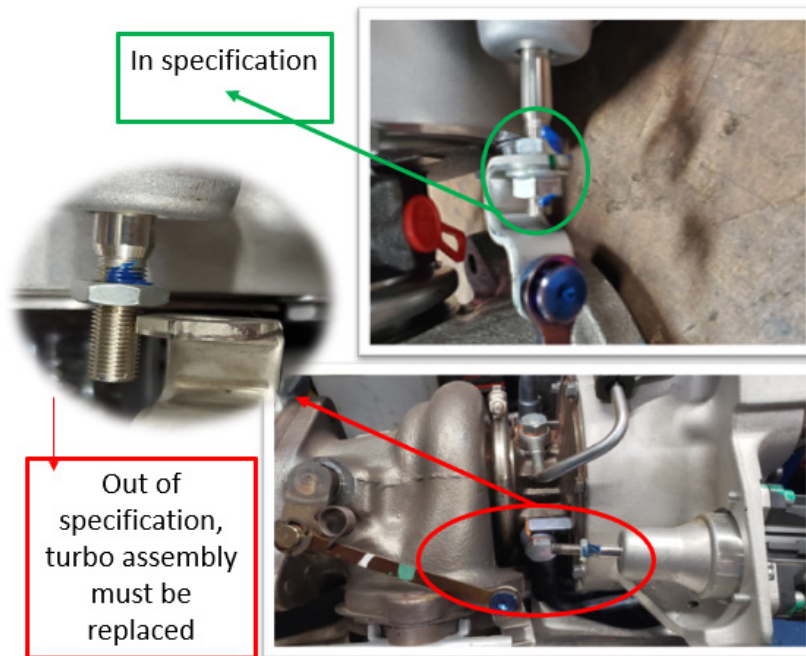
If the customer concern is a lack of boost with a Check Engine light on and DTC P0299 in memory, start by performing a visual inspection of the turbo area. SOA has received reports of the wastegate rod being disconnected and the retaining nut missing. The wastegate rod is not adjustable and the retainer nut should never be loosened. If this condition is confirmed, the turbo assembly must be replaced. If the retainer nut is in place, proceed with diagnostics per STIS for DTC P0299.

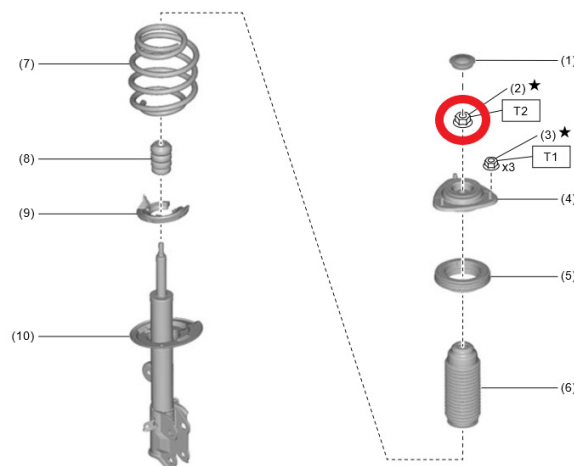
05 Noises from Strut Area

When diagnosing suspension noise, verify the strut mount nut (item #2 in the diagram below) is torqued to the correct specification listed in STIS for the vehicle being repaired. **NOTE:** this is a one-time use (indicated by the star) self-locking nut and should never be reused. It is a good practice to verify all suspension components are torqued to the proper specification listed in STIS for the model and year being repaired whenever dealing with suspension noises.

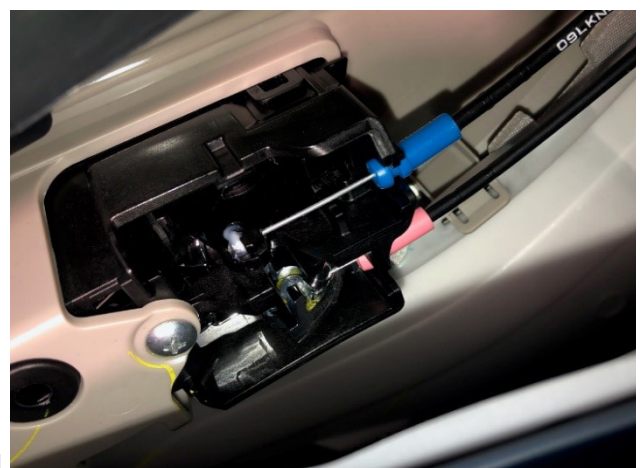
When presented with a customer concern regarding power door locks being inoperative, erratic, or rapid lock and unlocking, it is always important to not only check the door lock actuator but to also check the door lock cable set. Technicians should remember to inspect the cable from the actuator to the Door Inner Remote handle for free cable movement as well as ensure that the cable ball is securely placed in the inner door handle lock knob, as well as in the handle plate. If there is any abnormality found with the cable positioning, correct as needed, and recheck operation. If the door inner remote handle or the lock knob is faulty, replace the remote assembly. If the cable is deformed, replace the latch and actuator assembly. Shown here is a properly secured door lock cable and lever cable. Colors of the cable ends will vary year to year and model to model.

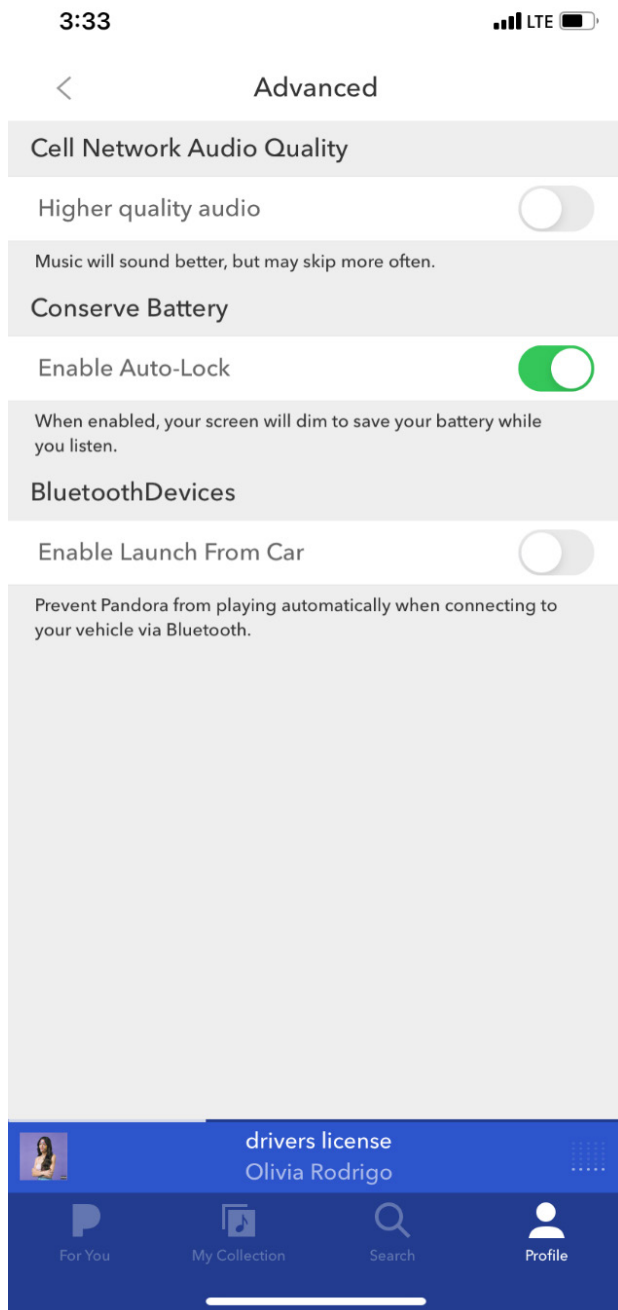
Apple Carplay (iOS)

There have been several reports of the Pandora application automatically launching while using Bluetooth, Apple Carplay or Android Auto. This can be resolved by adjusting settings within the app on the customer's phone. The Pandora app has an option to automatically launch the app when connecting a phone to the vehicle. This is ON by default. Customers can disable this in settings (Pandora-> Profile-> Settings Gear -> Advanced -> Toggle OFF – Launch from Car). Use the pictures below as reference.
