SERVICE BULLETIN

APPLICABILITY: 2022MY Outback Wilderness

NUMBER: 12-224-21

SUBJECT: Trailer Hitch Fascia Panel / Lack of Adhesion

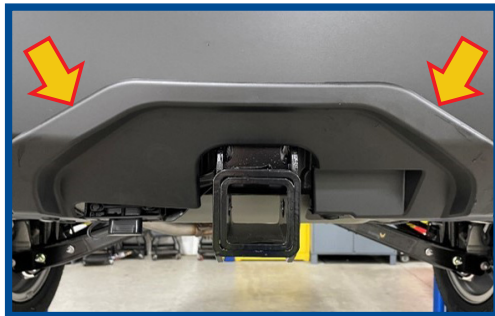
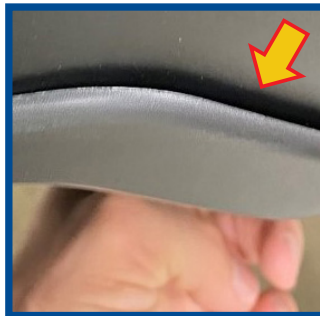
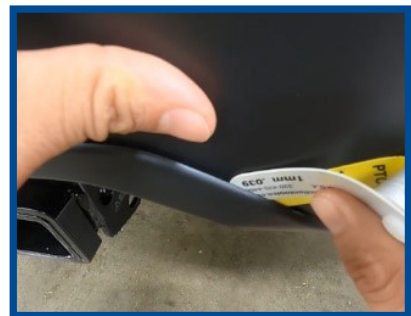
STEP 1) The fascia panel may appear to be seated. If pressure is applied to the bumper cover section above the fascia, the double-sided tape may separate.. Confirm the fascia panel to body fitment by pressing the bumper cover and inspecting the contact condition.

NOTE: The fascia panel does not need removal for the reinforcement repair to be performed.
