## TECHNICAL SERVICE BULLETIN

### Hard Top Headliner Loose And/Or Sagging

**21-2285**  
30 August 2021

Ford 2021 Bronco
---------------------

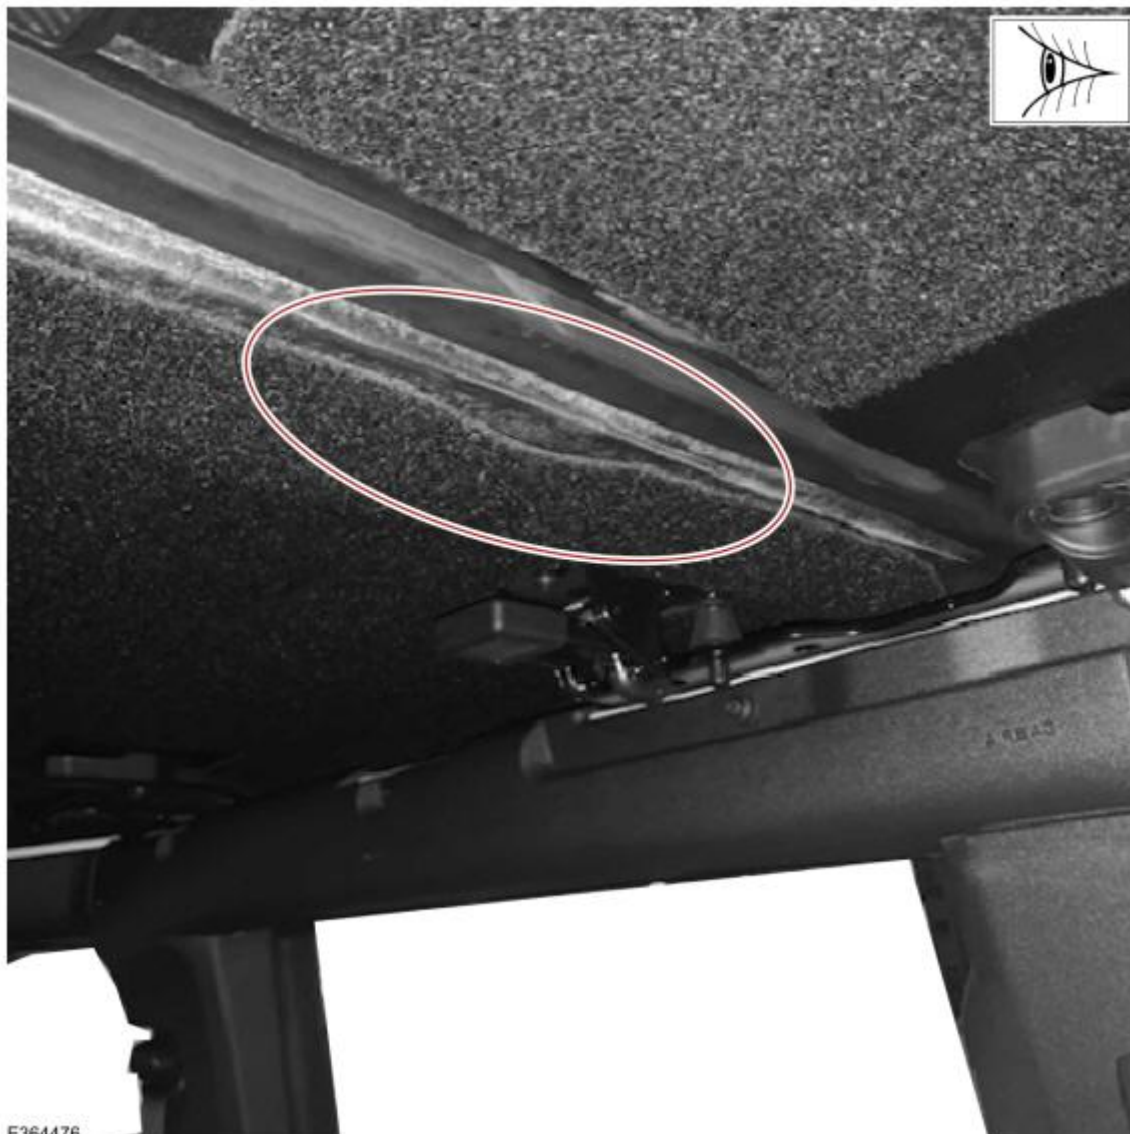
Figure 1

**Issue:** Some 2021 Bronco vehicles equipped with a hard top may exhibit a loose and/or sagging headliner. This may be due to the factory installation process. To correct the condition, follow the Service Procedure to re-adhere the headliner.

1. Inspect the interior headliner. Is the headliner loose and/or sagging? (Figure 1)
