SIB 51 17 21

TAILGATE WILL NOT OPEN COMPLETELY

E-Series	Model Description	Production Date
G05	X5 Sports Activity Vehicle	October 1, 2020- May 1, 2021
G07	X7 Sports Activity Vehicle	October 1, 2020- May 1, 2021

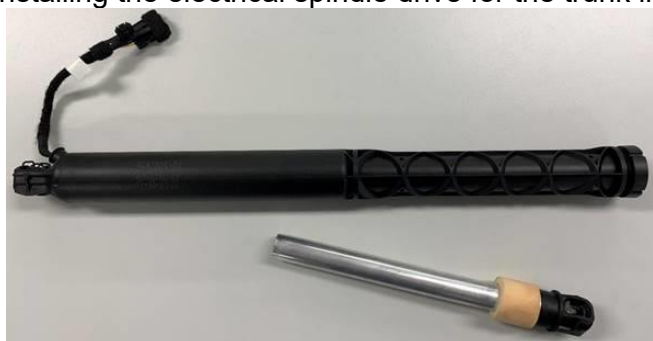
The tailgate spindle is damaged. This **ONLY** affects vehicles produced from October 1, 2020- May 1, 2021.

2. With the spindle removed, attempt to pull the silver extension rod from the body of the spindle as shown to the left.

3. If the spindle has come apart as shown above, replace the spindle drive. If the spindle drive has not come apart, re-install and continue troubleshooting, this bulletin does not apply.
