SIB 64 06 21

2021-07-26

DIFFERENT AIR TEMP FROM LEFT TO RIGHT OUT OF THE VENT

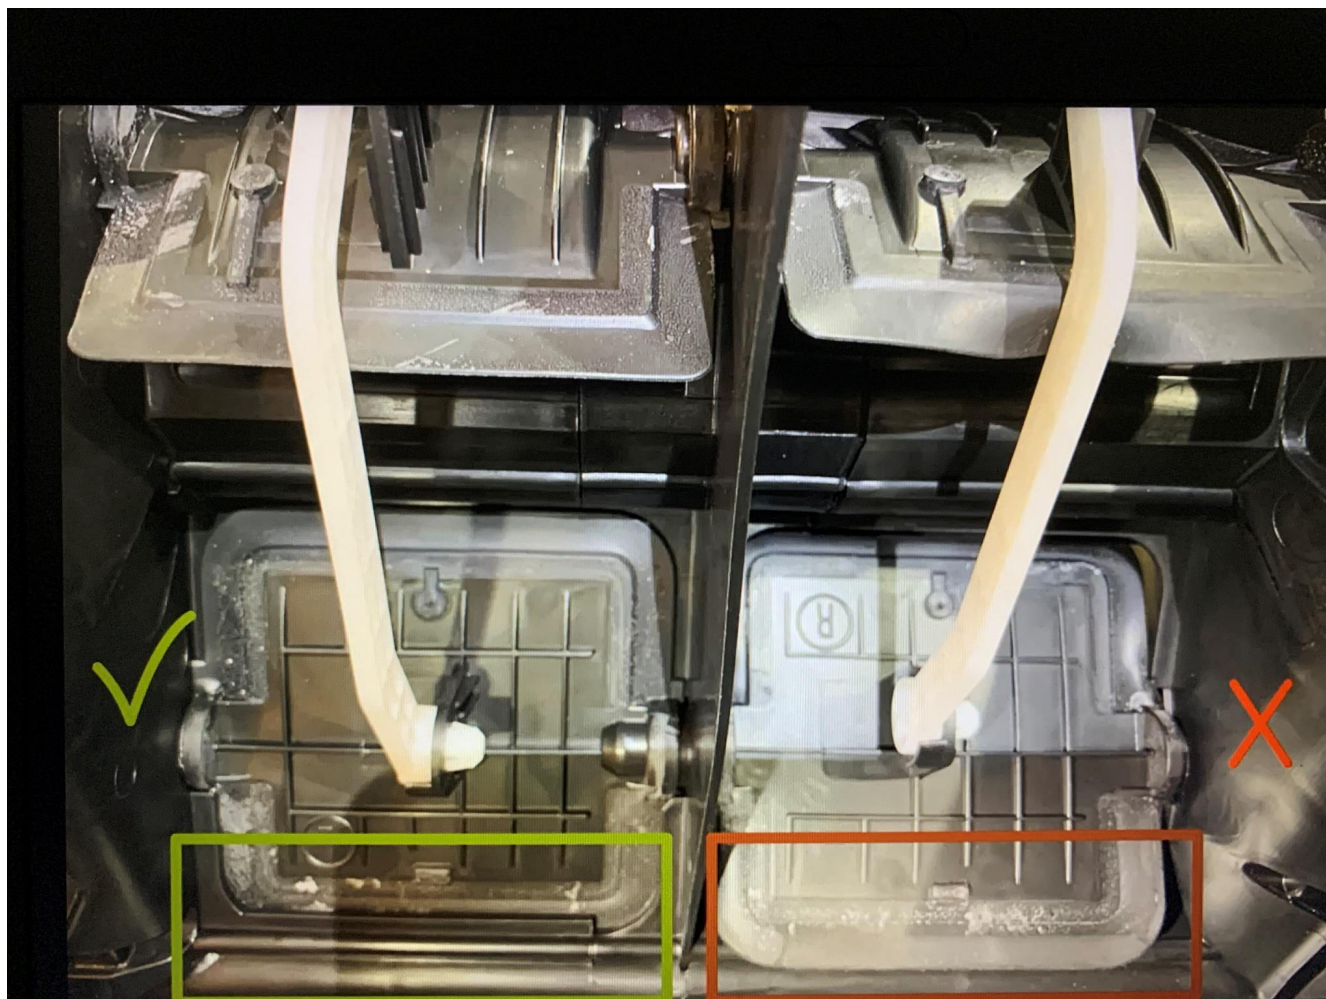
Due to the constant pressure on the end stop of the mixed air flap, it may become deformed and in some cases break off.

As a result, one of the air flap units may no longer move correctly

Test operation of the mixed air flap. Repair as needed.
