SIB 66 29 19

2021-07-06

TOP VIEW CAMERA: IMAGE IS MISALIGNED

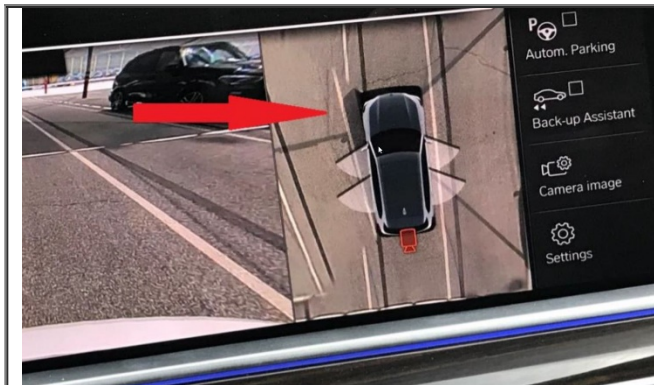
The top view image of the vehicle is misaligned when observed in the Control Information Display (CID). When the vehicle is parked in a parking spot with line markings, it is clearly noticed in the CID that the lines are not parallel to the side of the vehicle. This may be noticed on either the driver side, passenger side or both.

The arrow identifies the line which is shown as not parallel or straight alongside the vehicle.

Side view camera loose fitment in the exterior mirror bracket, causing changes to the top view image.

Reposition the camera in the exterior side view mirror with felt tape and / or software update with ISTA 4.26.3x or higher. Target Integration level (I-level) of S15A/S18A-20-11-500 or higher.
