SIM 64 02 21

2021-07-26

DIFFERENT AIR TEMP FROM LEFT TO RIGHT OUT OF THE VENT

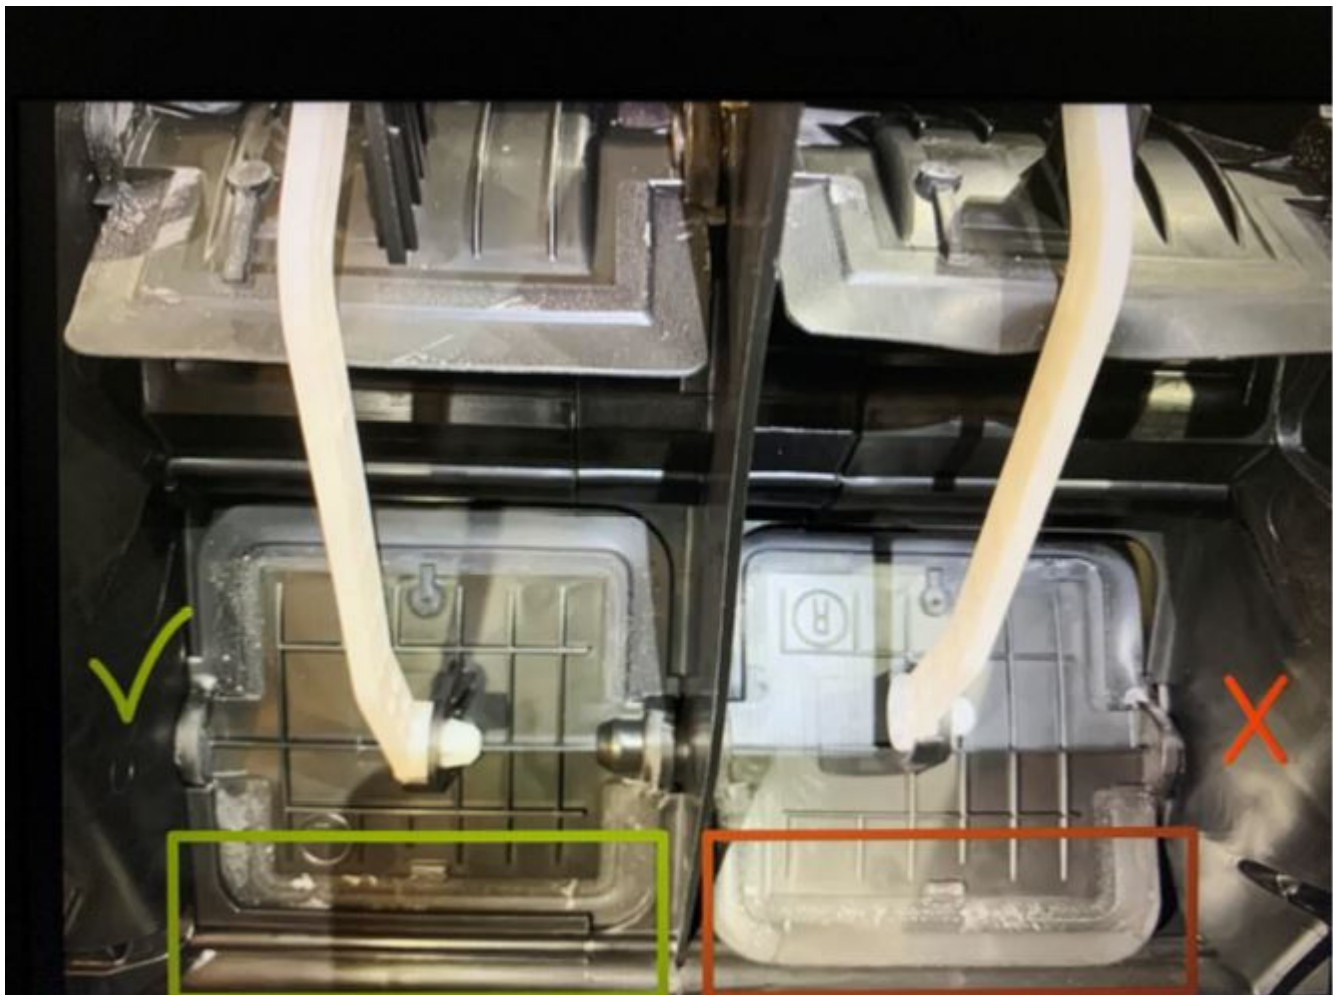
Due to the constant pressure on the end stop of the mixed air flap, it may become deformed and in some cases break off.

As a result, one of the air flap units may no longer move correctly

Test operation of the mixed air flap. Repair as needed.
