Technical product information

Topic	Electronic Parking Brake (EPB) functionality issues
Market area	Russische Föderation (5RU),Australia E04 Bentley rest Asia and Australia (6E04),China 796 VW Import Comp. Ltd (Vico), Beijing (6796),Germany E02 Bentley rest Europe (6E02),Japan E03 Bentley Japan (6E03),Korea, (South) E08 Bentley South Korea (6E08),United Arab Emirates E06 Bentley Middle East and Africa (6E06),United Kingdom E01 Bentley UK (6E01),United States E05 Bentley USA and rest America (6E05)
Brand	Bentley
Transaction No.	2062184/2
Level	EH
Status	Approval
Release date

New Continental GT/GTC and New Flying Spur

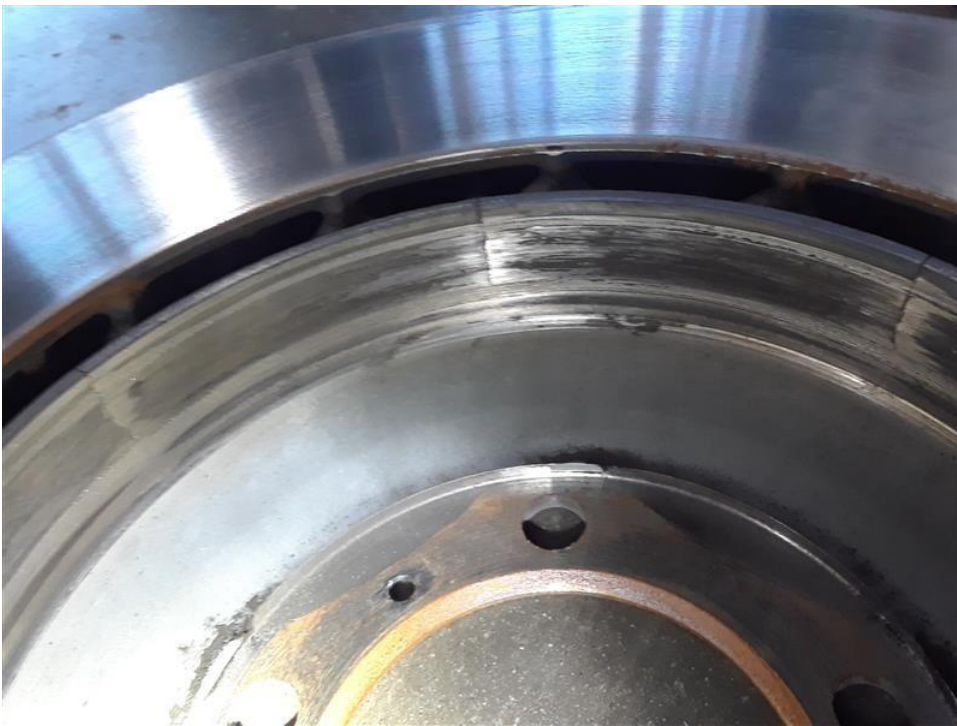
- Right and left hand rear brake discs – See example shown in Figure 3

1) Carry out a full inspection of the (Electronic Parking Brake EPB) system including the following components:

IMPORTANT NOTE: Please attach photographs and details of any issues found to a new or the existing DISS query
