# Technical product information

<b>Topic</b>	Warning light illuminated within the DIP - DTC C103711 - Evident within Address 74
<b>Market area</b>	Russische Föderation (5RU),Australia E04 Bentley rest Asia and Australia (6E04),China 796 VW Import Comp. Ltd (Vico), Beijing (6796),Germany E02 Bentley rest Europe (6E02),Japan E03 Bentley Japan (6E03),Korea, (South) E08 Bentley South Korea (6E08),United Arab Emirates E06 Bentley Middle East and Africa (6E06),United Kingdom E01 Bentley UK (6E01),United States E05 Bentley USA and rest America (6E05)
<b>Brand</b>	Bentley
<b>Transaction No.</b>	2064338/1
<b>Level</b>	EH
<b>Status</b>	Approval
<b>Release date</b>

## New Continental GT /GTC and New Flying Spur

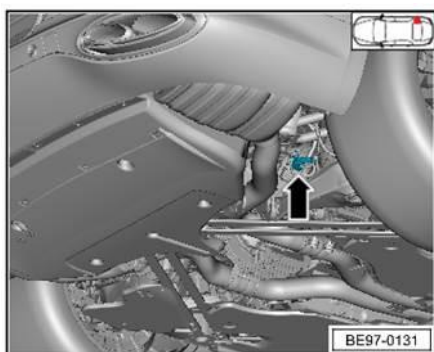
- Rear Right Height sensor (G77) connection – Visual and pull check
- Referring to Figure 1 - Perform a wiring integrity check between sensor (G77) and J775

2) In the event that wiring is found to be damaged, the wiring should be repaired as per the applicable Rep.Gr

3) If no fault is found during the wiring checks - Replace the level sensor (G77) - Rep.Gr 43

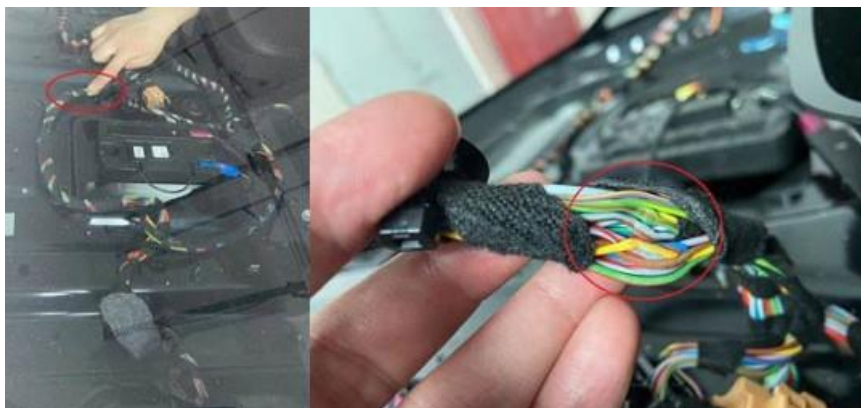
- Figure 2 shows examples of damaged wiring under parcel shelf

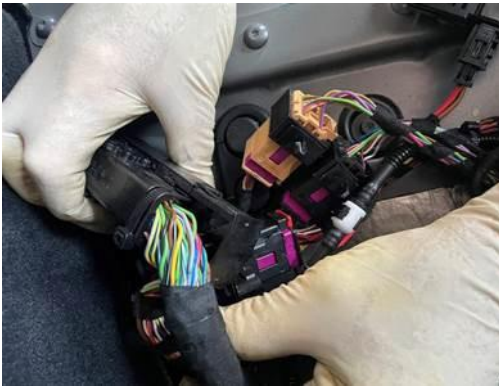
Figure 3

TIP: Inspect the wiring around the Chassis control unit bracket for any issues/damage (Figure 3)
