Bulletin No.: PIT5834D

PIT5834D A/C Blows Warm Intermittently Or Takes A Long Time To Start Cooling

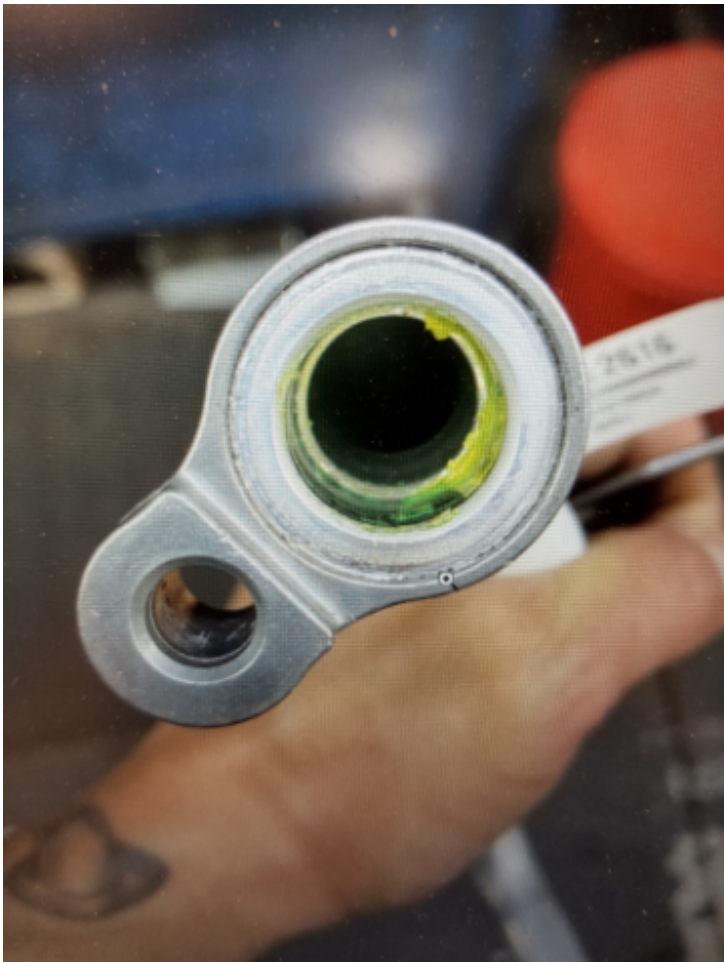
Involved Region or Country:	North America
Condition:	A/C is slow to cool, takes longer to blow cool air when compared to like vehicle or if the vehicles refrigerant needs to be evacuated for another repair.
Cause:	Possible A/C refrigerant contamination.

If you duplicate this condition and the vehicle VIN is included in the above list, recover the refrigerant using the GE-50957 Contaminated Refrigerant Recovery Machine. Remove the compressor solenoid, the inlet and outlet lines from the compressor and condenser and at the TXV. Take pictures at each of these points and attach them to the case. (Pictures at ALL of these points are required for review.) Your case will be reviewed and you will be contacted directly.
