Bulletin No.: PIT5847

PIT5847 SES Light - Reduced Power - DIC Warning Messages - Reduced Steering Message - Stabilitrack Message

Brand:	Model:	Model Years:	VIN:		Engine:	Transmissions:
			from	to		
Chevrolet	Blazer	2019 - 2021	All	All	All	All

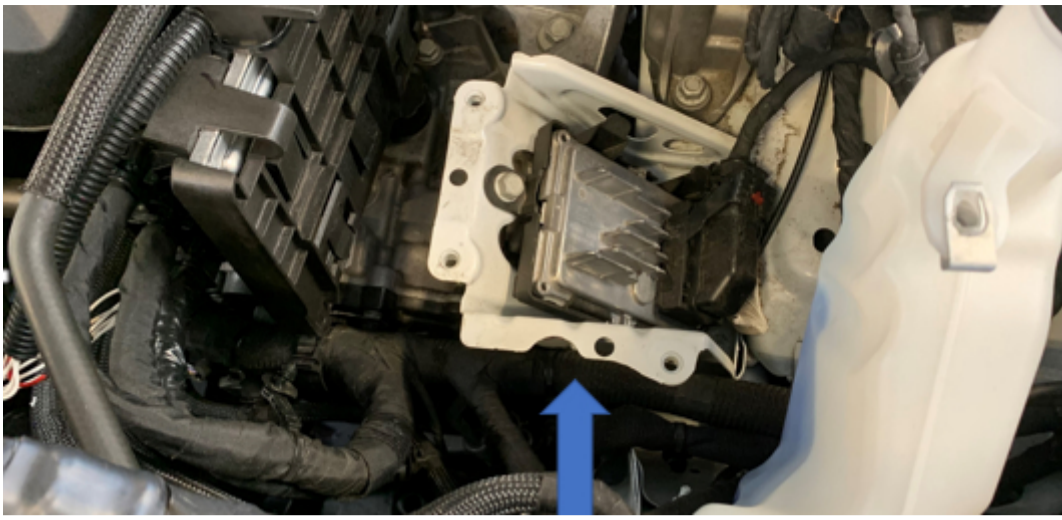
Battery and battery tray are removed to show the area of concern.

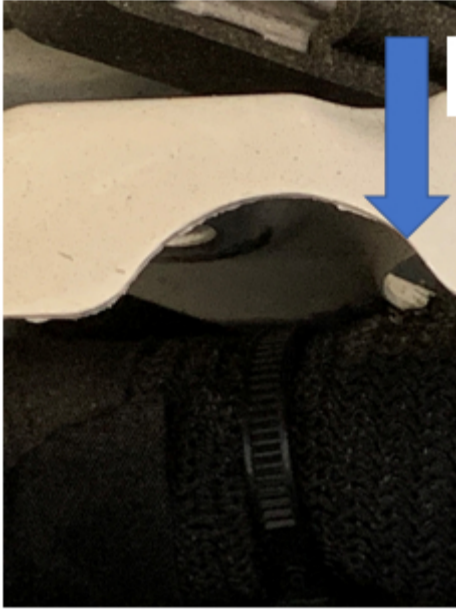
Close up of area where harness may chafe.

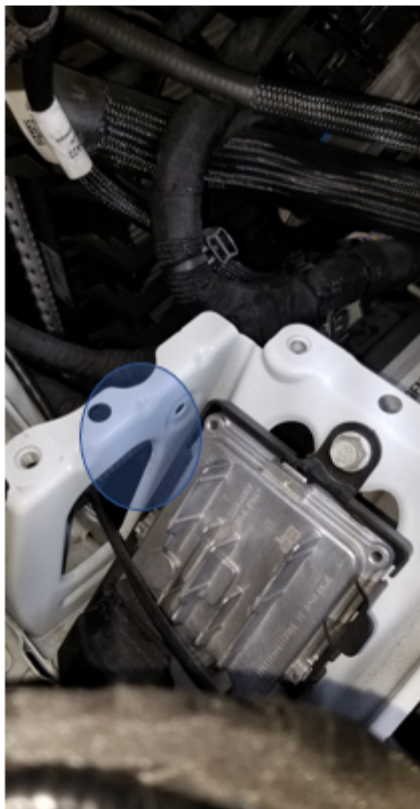
Harness may chafe in the areas shown in the photos above and below.

Reroute or properly secure the harness to prevent further damage.

It may also be necessary to install a piece of heater hose, conduit or both over the harness to prevent a reoccurrence of the concern.

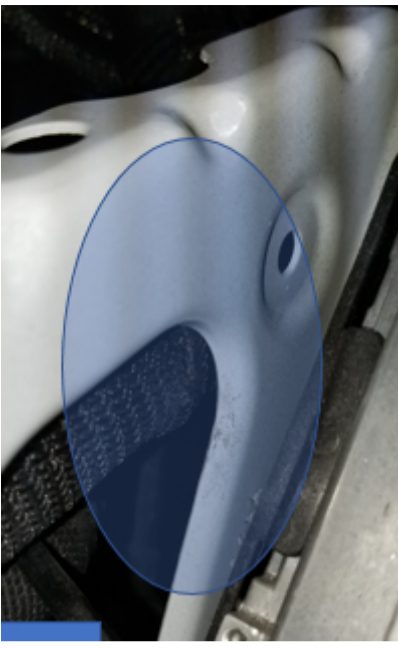
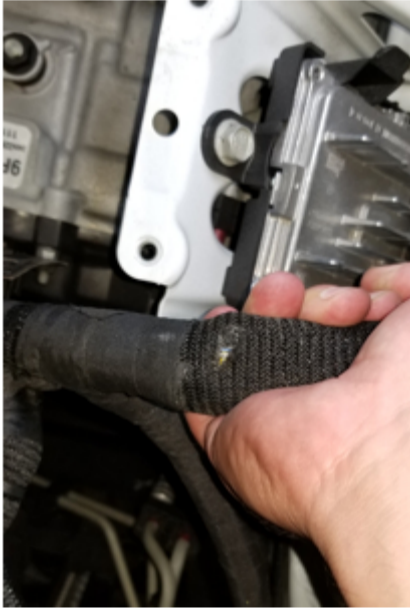
Above shows a harness that was chaffed by the bracket.

If damage is found repair any damaged circuits and tape up the harness.
