# Preliminary Information

## PIP5811 Crankshaft Balancer Contacting Timing Cover on Replacement Engine

| Condition | Crankshaft Balancer Pulley Contacting Timing Cover After Installation on Replacement Engine Part Numbers 19368174 and 19368176 |
| Cause | Incorrect Crankshaft Timing Gear Installed |

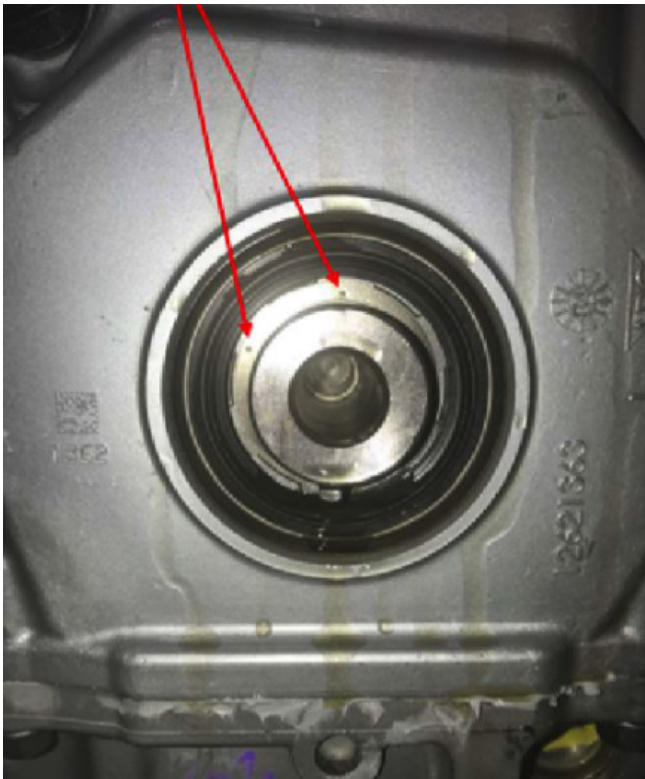
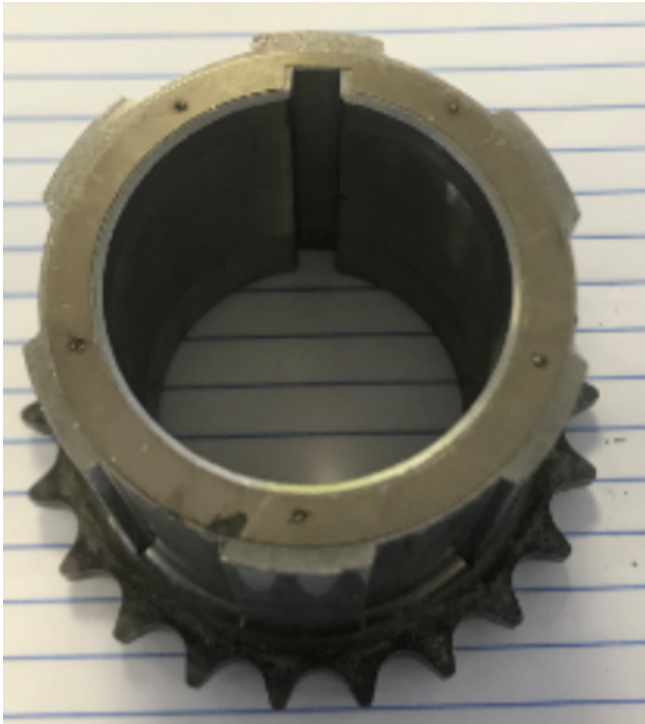
To identify if the engine was assembled with the incorrect crankshaft timing gear inspect for 5 dimples on the crankshaft timing gear (the incorrect gear will NOT have these dimples present), the dimples should be visible with the cover installed and balancer removed (see below):

If it has been confirmed that the lower crankshaft timing gear is incorrect, crankshaft timing gear P/N 12631214 along with a new oil pump will need to be installed.

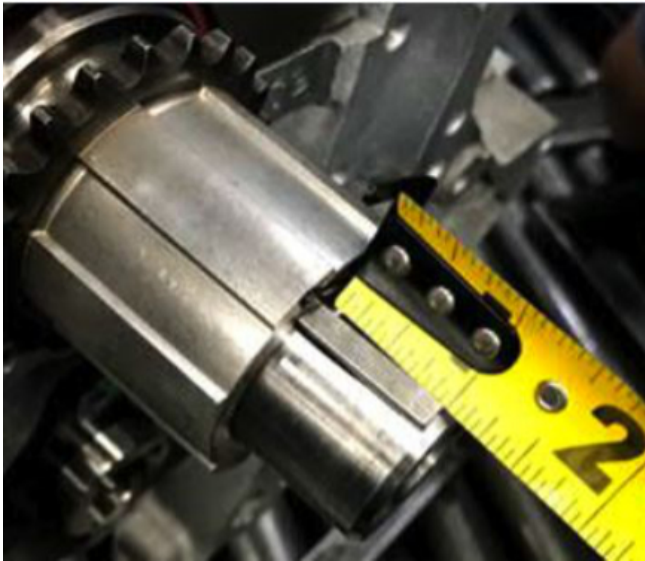
Further confirmation can be made with the timing cover of and measuring from the end of the crankshaft to the end of the gear (see below), this measurement should be approximately 1 1/16" (27.0mm).
