# PIC6441 Replacing & Programming the K218 - Front Suspension Leveling / Lifting Hydraulic Power Pack Module

Brand:	Model:	Model Years:	VIN:		Engine	Transmissions:
			from	to	Engine:	Transmissions.
Chevrolet	Corvette	2020 - 2021	All	All	All	All

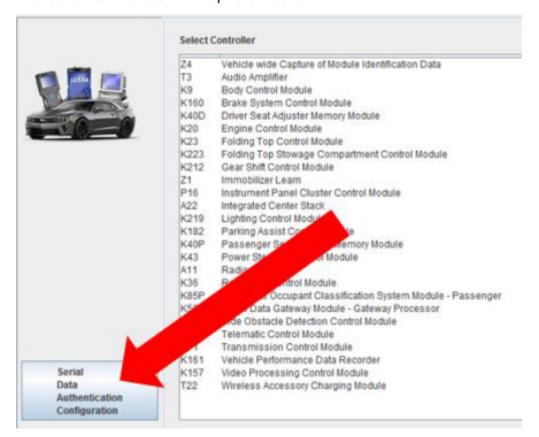
After this has been verified, manually select the "Serial Data Authentication Configuration" selection, as found in

This button can be seen in the photo below.

Once that has run and completed successfully, the regular SPS programming selection for this module should be selected, and it should successfully complete.
