Preliminary Information

PIP5814 Unable To Program New RDCCM 84849877

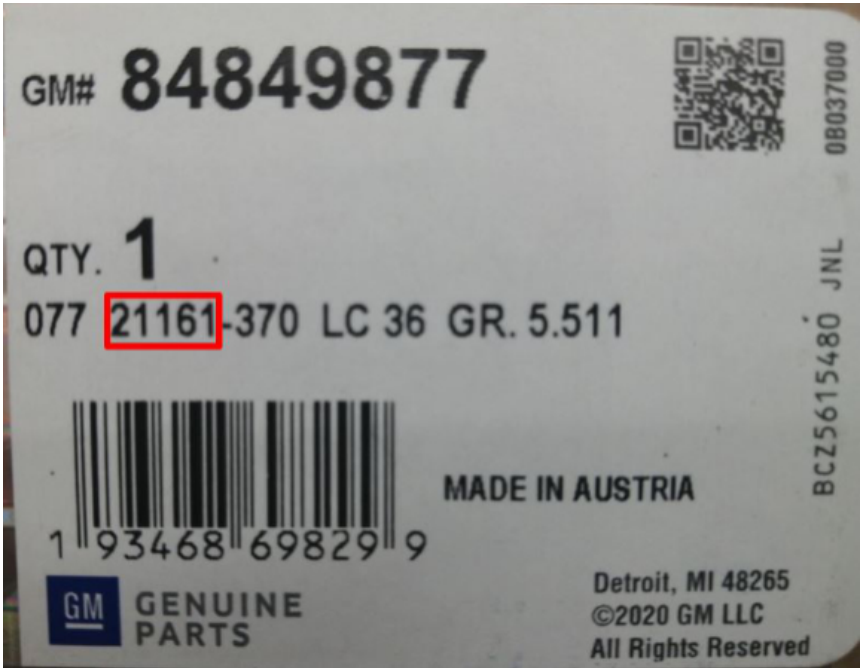
If the above conditions have been met it is possible that the module you installed was missing internal files to allow programming.

Verify the date code on the shipping label to be between 21103 and 21183 as shown below.

A part alert was sent to GM PDC and all suspect parts at the PDC were returned however parts in dealer inventory could still be suspect. If you find any of these parts within this date range please return them to CCA.

Parts ordered after 7/16/2021 are known good stock. Regardless of the date code on the module any part with date code after 21195 on the shipping label should be considered known good stock that was revalidated before shipping to CCA to be packaged for dealer sale.
