Preliminary Information

PIP5792B 6L80 6L90 8L90 10L80 10L000 Equipped Vehicles With A Harsh Shift Shudder Surge Stall Or High Transmission Fluid Temperature Concern With Low Mileage

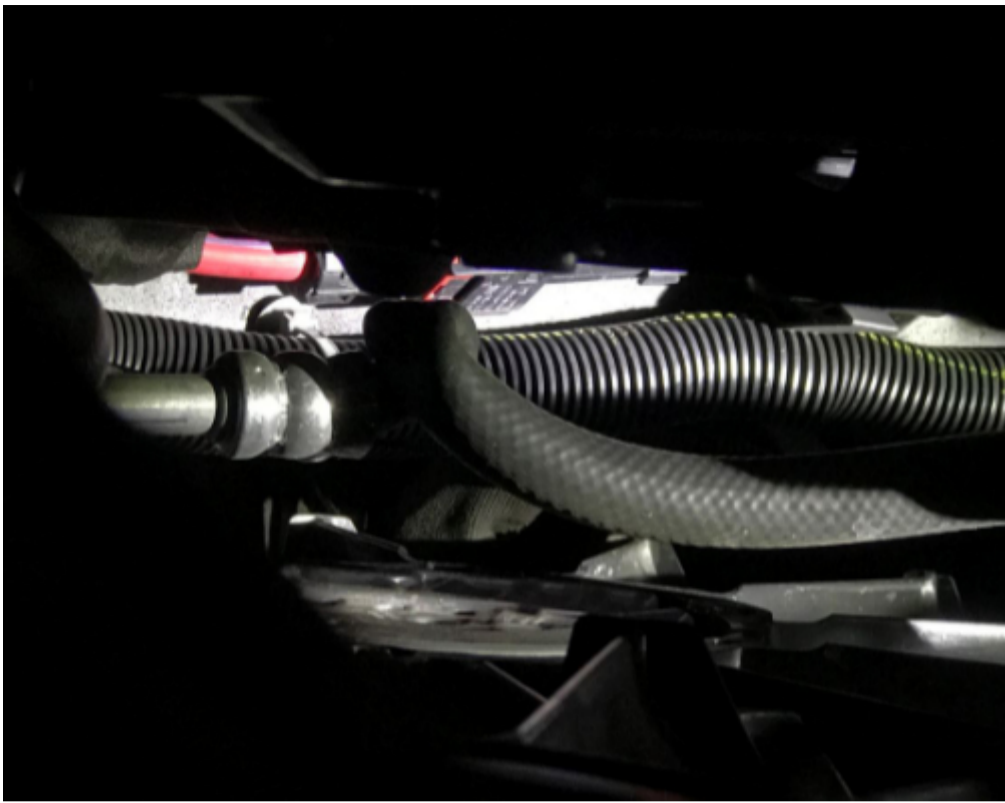
Involved Region or Country	North America
Condition	Customers may comment on harsh shifts, shudder, surge or stall. Customers may also comment on above normal transmission fluid temperature.
Cause	Root cause may be a twisted cooler line on low mileage vehicles.

Inspect for a twisted cooler line, example shown in the picture below.

If the cooler line is twisted disconnect the cooler line from the transmission auxiliary cooler and untwist it then reconnect the cooler line.

If no concerns are found with the rubber being misshaped check the transmission fluid level following SI and add fluid if needed.

If the cooler line is misshaped the cooler line should be replaced then check the transmission fluid level following SI and add fluid if needed.
