Bulletin No.: PIT5834C

PIT5834C A/C Blows Warm Intermittently Or Takes A Long Time To Start Cooling

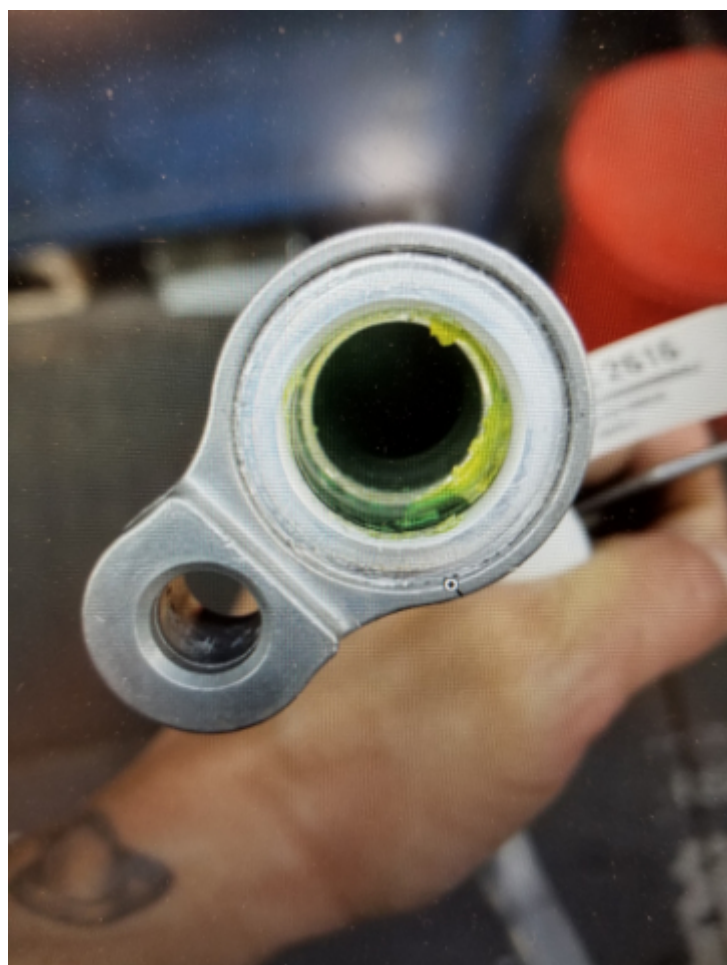
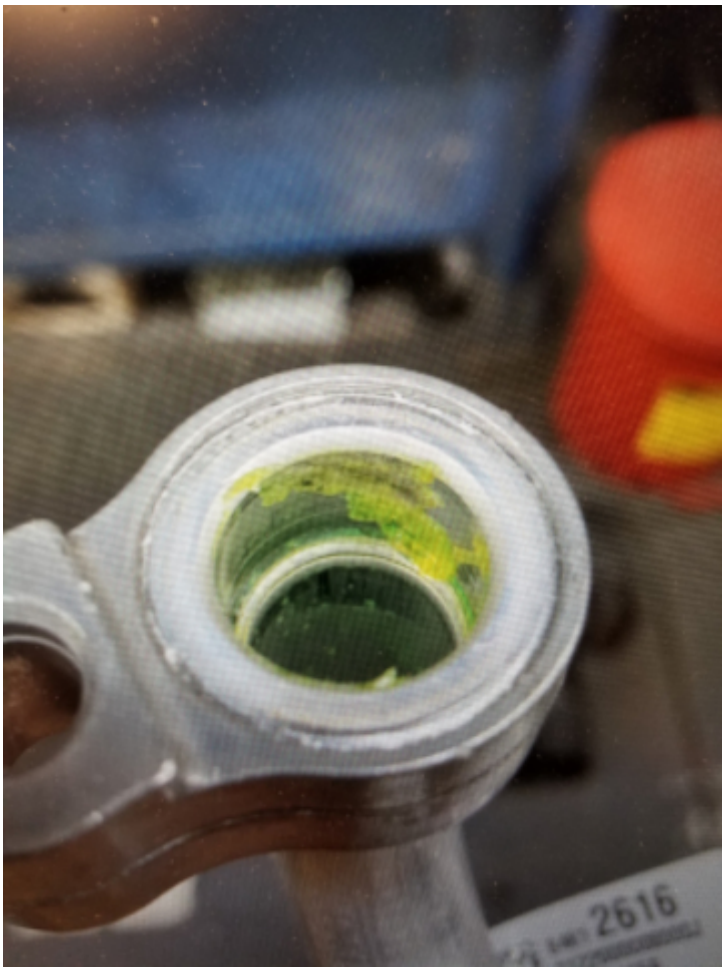
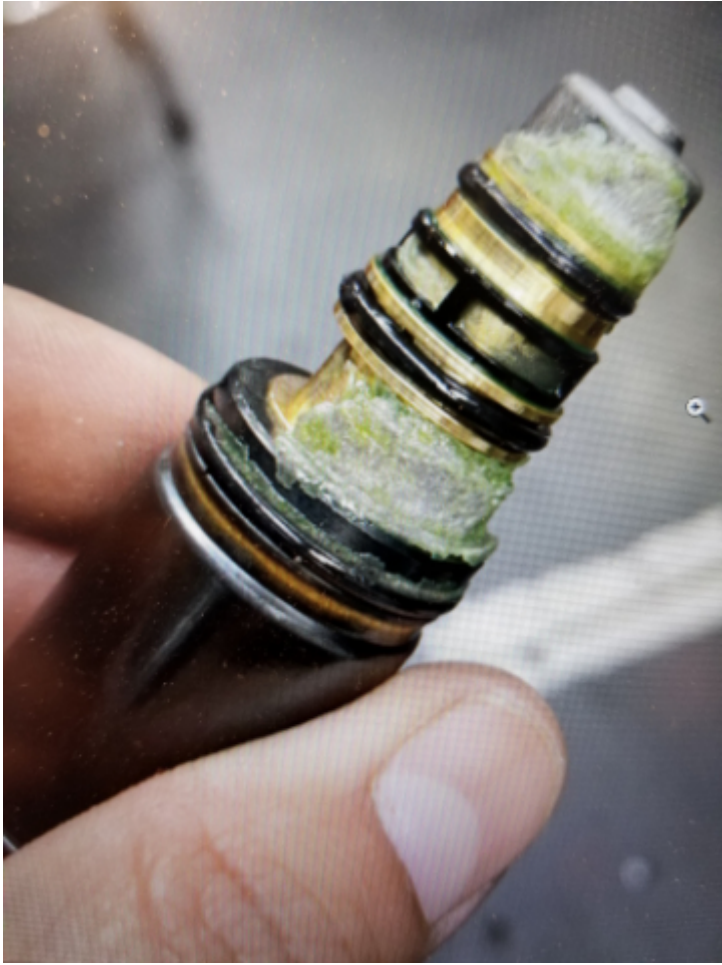
Involved Region or Country:	North America
Condition:	A/C is slow to cool, takes longer to blow cool air when compared to like vehicle or if the vehicles refrigerant needs to be evacuated for another repair.
Cause:	Possible A/C refrigerant contamination.

If you duplicate this condition and the vehicle VIN is included in the above list, recover the refrigerant using the GE-50957 Contaminated Refrigerant Recovery Machine. Remove the compressor solenoid , the inlet and outlet lines from the condenser and at the TXV and look for contamination like illustrated in the pictures below. If you have this contamination, take pictures of the solenoid, TXV and each of the fittings, open a TAC case and attach them to the case. (Pictures at all these points are required for review.) Your case will be reviewed and you will be contacted directly. If you do not see visible contamination like below reinstall the lines and diagnose using the performance chart and diagnostics in Service Information.
