Preliminary Information

PIP5496C Fuel Tank Hard To Fill Possible MIL With DTC P0446

Models

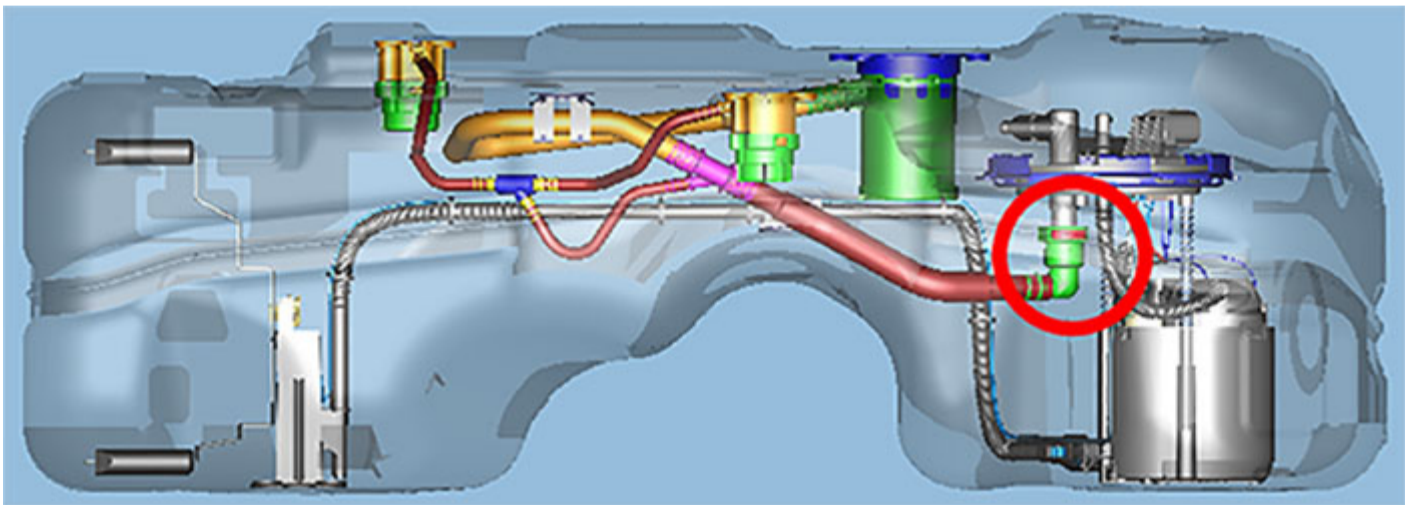
Involved Region or Country	North America
Condition	Fuel tank hard to fill with fuel, evaporative emission canister saturated with fuel and possible DTC P0446.
Cause	Vent hose disconnected from fuel pump module assembly inside fuel tank.

Reconnect fuel vent hose to fuel pump module inside fuel tank. Reference picture below showing properly connected fuel vent hose.

Also inspect evaporative emission canister for fuel saturation and replace canister as needed.
