Bulletin No.: PIT4261G Published date: 06/16/2021

# **Preliminary Information**

## PIT4261G Tire Sidewall Irregularities

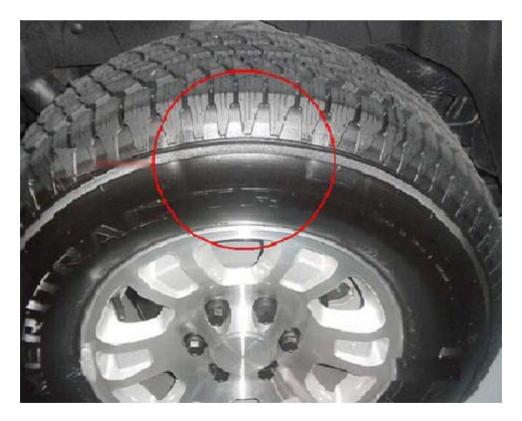
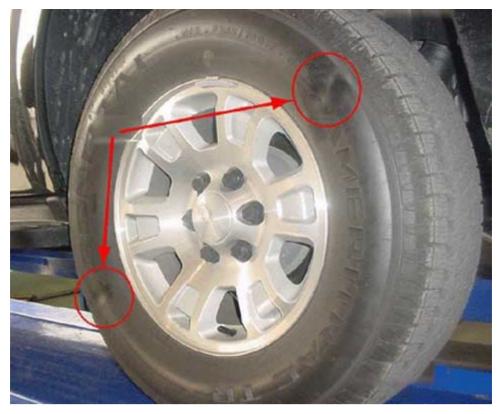
Slight sidewall indentations are a common characteristic of radial tire construction. These indentations are more noticeable on larger size tires having a larger side wall height. Radial tire body construction includes individual cords that run parallel to each other from bead to bead (down the sidewall, across the tread and up the other sidewall). These cords will overlap at points on the circumference of the tire. When the tire is mounted and inflated, it is free to naturally expand. The overlapped areas may create slight indentations, undulations, or protrusions since the stretching capacity of the overlapped area is slightly different than the rest of tire sidewall area.

The following two photo's show examples of tires with a sidewall indentation.

This is a visual condition that will not affect durability, reliability or performance of the tires. Tire replacement to address this condition is not recommended and will lead to customer dissatisfaction as the replacement tires will likely have the same or similar condition.
