Preliminary Information

PIT5802B Front Floor Console Cooler Inoperative With DTC U1144 Models

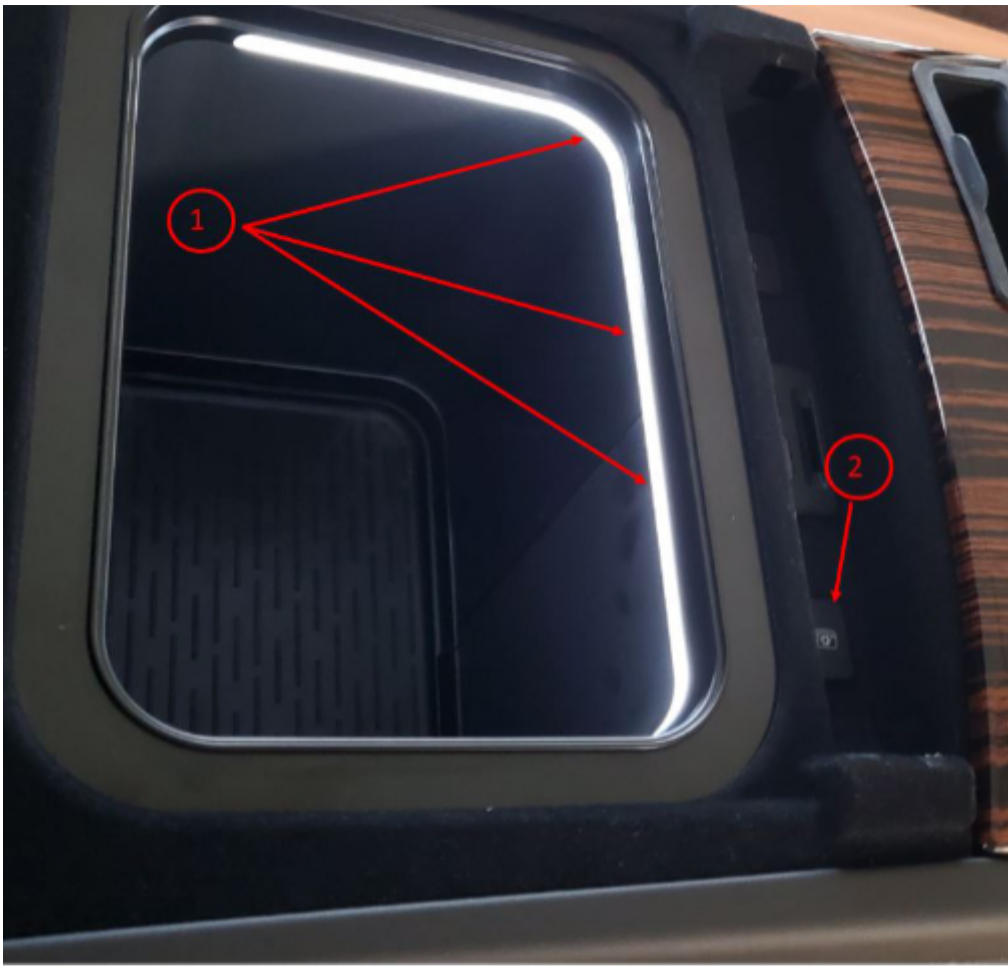
Involved Region or Country	North America and Middle East
Additional Options (RPO)	DCK - Front Floor Console Cooler
Condition	<p>Condition 1: Some customers may notice when the Front Floor Console Cooler lid is open, the upper bin light (1) is inoperative. Also, when trying to turn on the cooler using the switch (2), the LED's in the switch do not turn on and the cooler is inoperative. When checking for DTC's a U1144 will be set.</p> <p>Condition 2: Some customers may notice when the Front Floor Console Cooler lid is open, the upper bin light (1) does operate. When they try to turn on the cooler using the switch (2), the LED's in the switch do not turn on and the cooler is inoperative. When checking for DTC's a U1144 will be set. In addition to the console cooler issue, a customer may also notice other issues with the console USB ports and Navigation/SD card slot.</p>
Cause	<p>Condition 1: This concern could be caused by a software issue within the Front Floor Console Cooler.</p> <p>Condition 2: The cause of this concern could be that the S145 Console Cooler Switch connector was accidentally swapped with the X23 Multimedia Receptacle X1 connector. The cooler switch and Multimedia Receptacle are located next to each other and both connectors are interchangeable.</p>

Condition 1: Engineering has released new Front Floor Console Coolers with updated software. These new coolers are currently available in CCA stock. To correct this concern, replace the Front Floor Console Cooler with one from CCA stock.

Condition 2: To determine if the connectors are swapped, use the SI connector end view and inspect the number of wires both at the S145 Console Cooler Switch and at the X23 Multimedia Receptacle X1 connector to determine if the connectors are swapped. If the connectors are swapped then reverse them to correct the concern.
