Bulletin No.: PIP5812

PIP5812 Diagnostic Tip: Potential For Oil/Moisture Condensate Freezing Up in Turbocharger Wastegate Regulator Solenoid Valve (TCV)

Brand:	Model:	Model Years:	VIN:		Engine:	Transmissions:
			from	to		
Chevrolet	Cruze	2016 - 2019	All	All	1.4 LE2	All

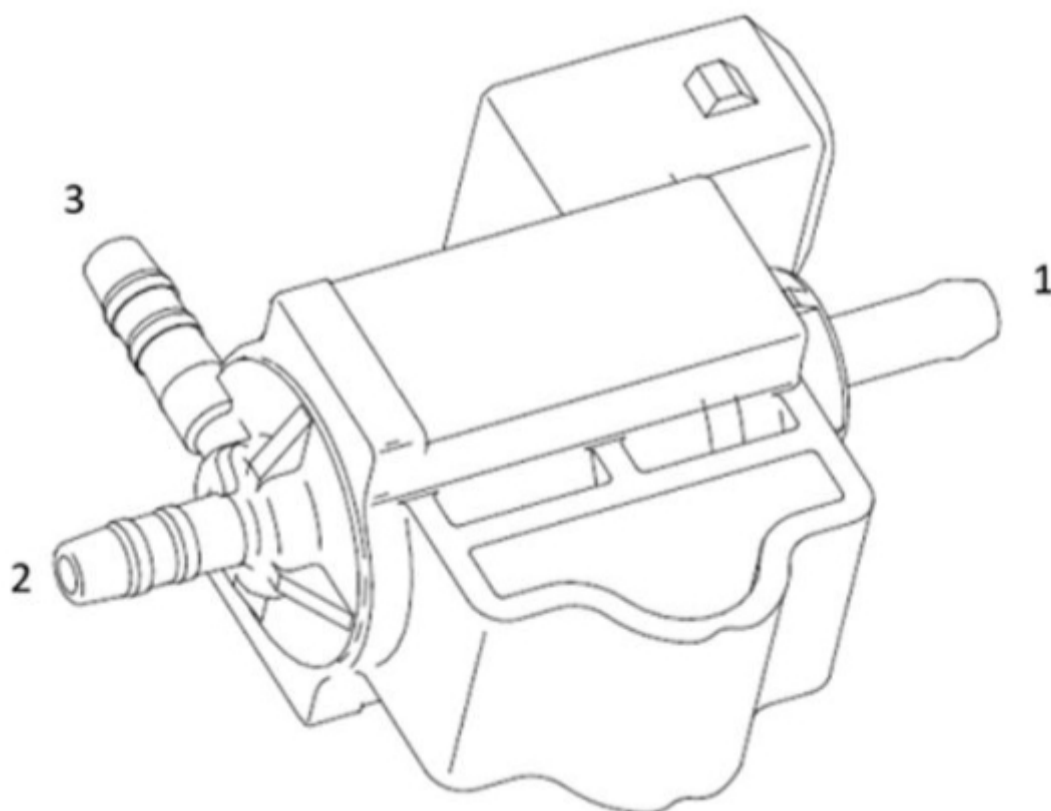
Involved Region or Country:	North America ,Argentina, Brazil, Colombia, Ecuador, Paraguay, Uruguay, Israel, Palestine, Middle East, Israel, Chile, Peru, Korea, China, Thailand, Australia, New Zealand, Egypt, Africa
Condition:	Possible DTC P0234 P0299 that can occur during cold weather driving.
Cause:	Oil/moisture condensate freezing up in Turbocharger Wastegate Regulator Solenoid Valve (TCV).

Note: Check port #2 to assure the spring gets lifted off the seat. This will be determined by the compressed air not dead-heading when applied to port #2. When applying air to this port a small amount of air should be observed at port #3 and even less air will be noticed at port #1. If this does not happen, the TCV plunger may have hardend deposits from hot operating conditions which will impede TCV plunger movment and the Turbocharger Wastegate Regulator Solenoid Valve should be replaced.

1. **Remove Turbocharger Wastegate Regulator Solenoid Valve**
2. **Drain Turbocharger Wastegate Regulator Solenoid Valve (TCV) by turning valve upside down.**
3. **Using clean shop air regulated to 15-20 PSI (103kPa), blow through all three ports (1, 2 &3) for 5 seconds each. Repeat twice.**

4. Reinstall Turbocharger Wastegate Solenoid Valve (TCV) using the latest service information and clear all DTC's using GDS and evaluate.
