Audio Update Phase 3 (Pioneer)

Service Category Audio/Visual/Telematics

Market USA

YEAR(S)	MODEL(S)	ADDITIONAL INFORMATION
2019	ES300H, ES350, RC F, RC300, RC350, UX200, UX250H	
2019 - 2020	NX300, NX300H

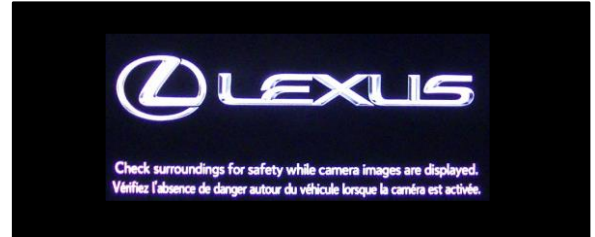
Figure 1.

1. Confirm the software version.
 - A. Start the engine. The Lexus emblem will display on the radio screen.

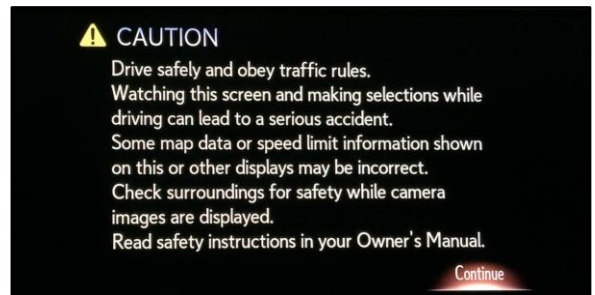
Figure 2.

- B. Wait for the display to switch to the Caution screen, then select Continue.

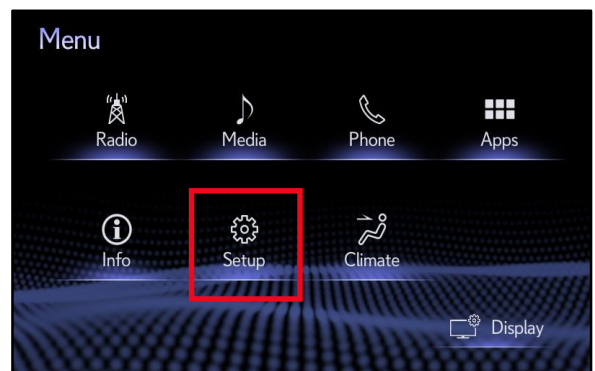
Figure 3.

- D. Press the Menu button, then select Setup.

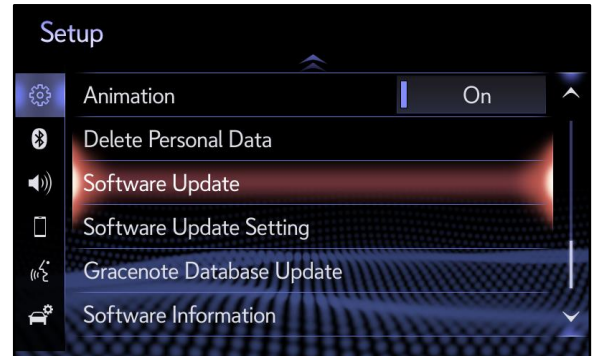
Figure 4.

E. Scroll to and select Software Update.

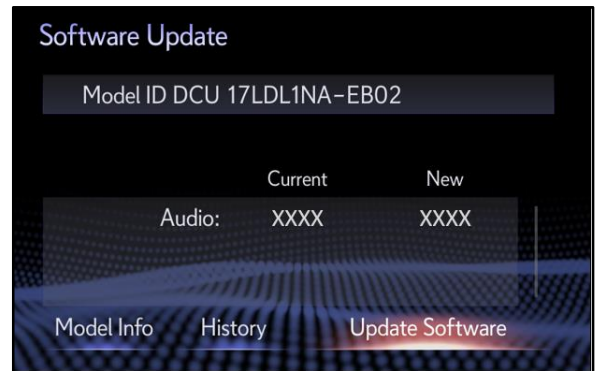
Figure 5.

F. Confirm the current audio version.

Is the current audio version earlier than 1102?

- **YES** — Continue to step 2.
- **NO** — This bulletin does NOT apply. Continue diagnosis using the applicable Repair Manual.
