Preliminary Information

PIP5806C Intermittent Extended Crank No Start And A Possible DTC P0341 Set

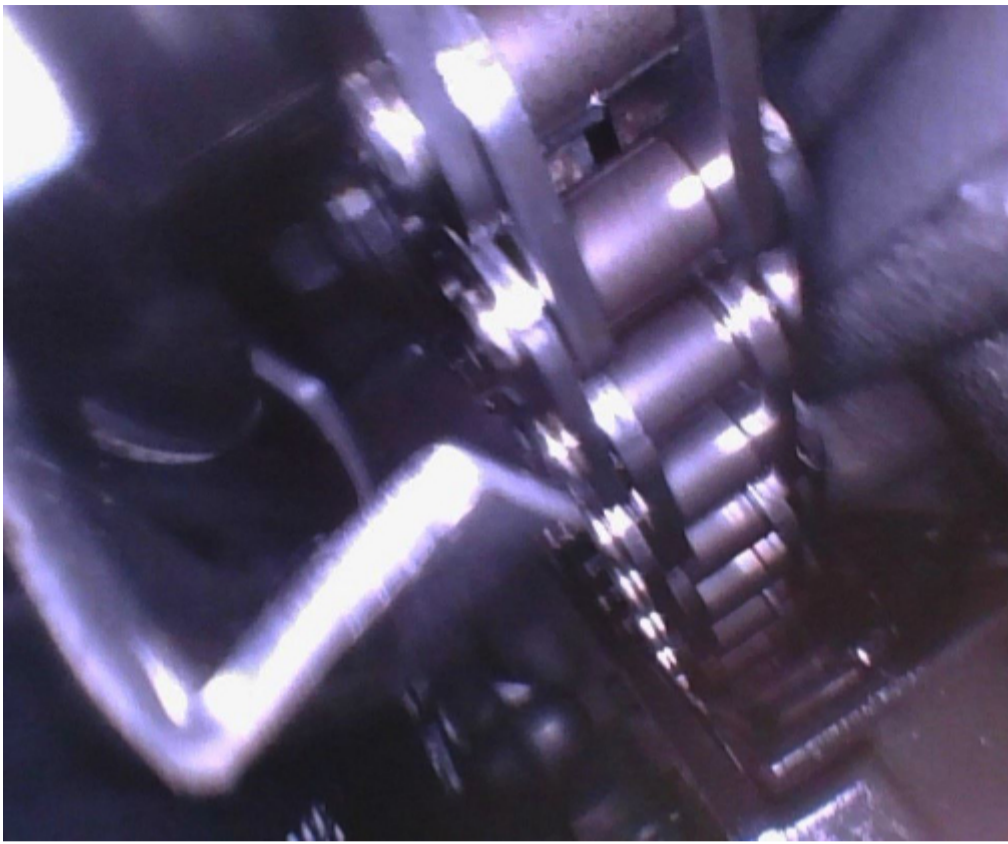
It is necessary to roll the engine over by hand (up to two revolutions) to inspect each wheel segment. See the picture below:

Remove the camshaft position sensor and use a borescope to inspect the camshaft trigger wheel for coming in contact with the timing chain. If the trigger wheel is coming into contact with the timing chain at any point, it will be necessary to replace the trigger wheel.

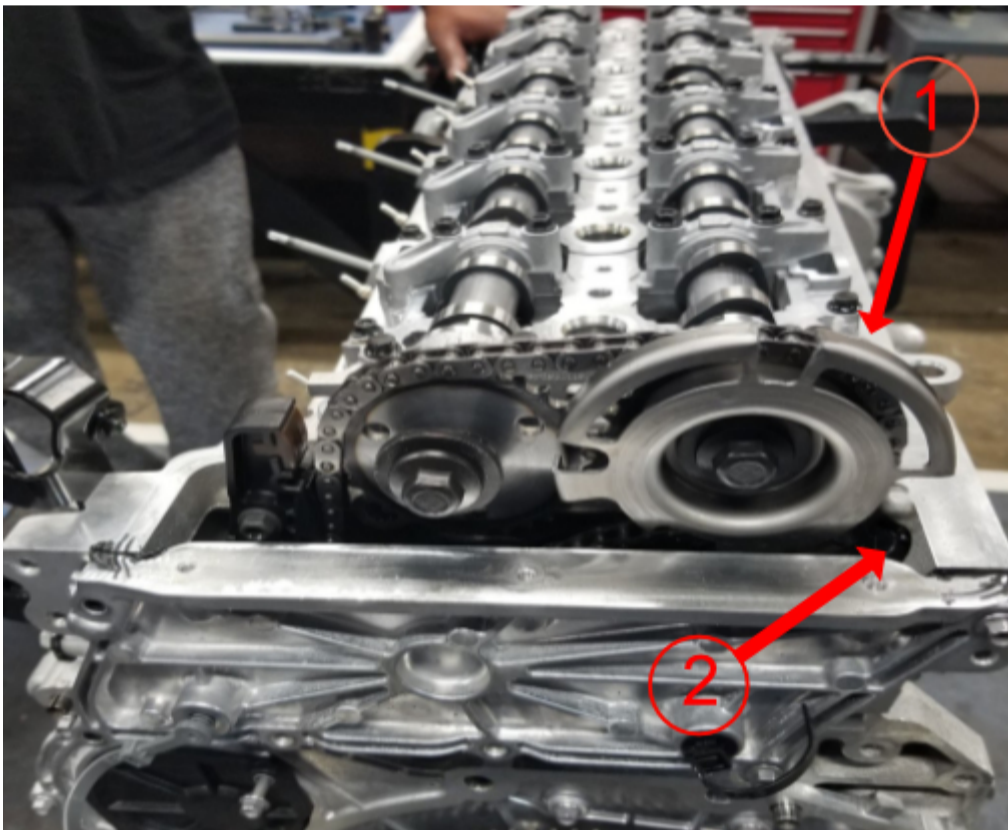
Below are reference pictures of a good trigger wheel and chain:

1. Camshaft Position Reluctor Wheel

2. Camshaft Position Sensor

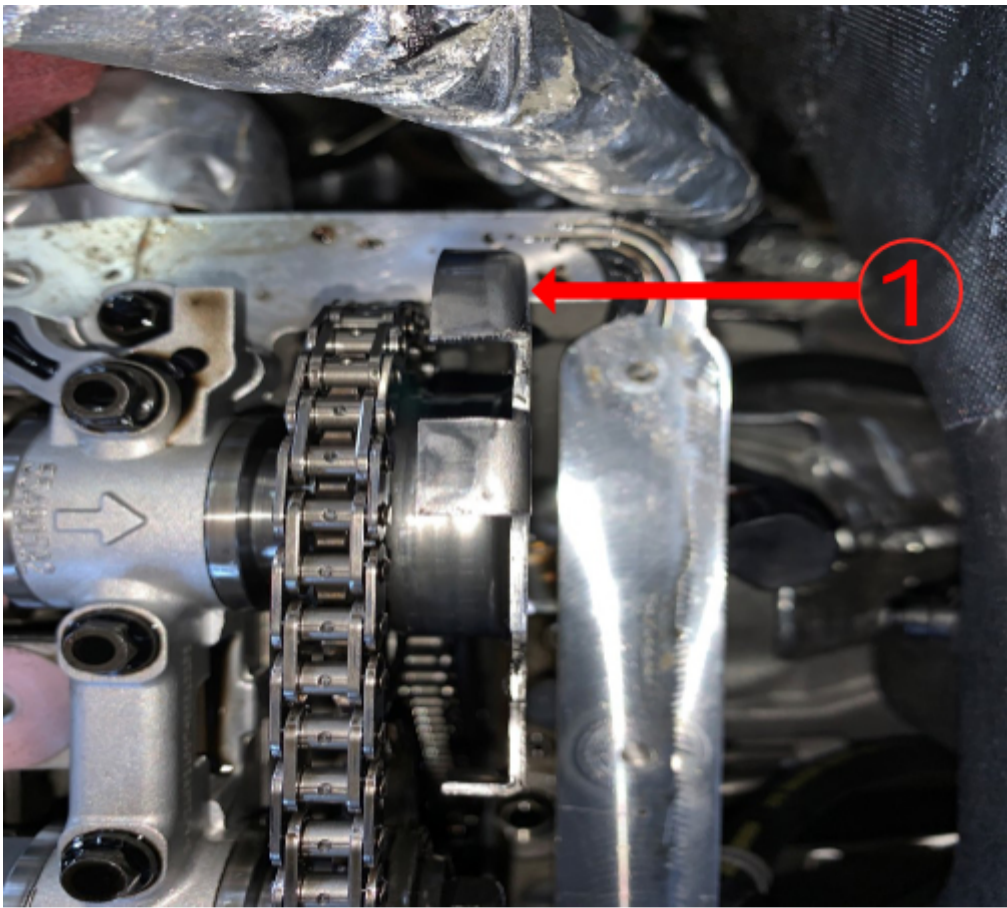
1. Camshaft Position Reluctor Wheel
