# Preliminary Information

## PIT5839B Radio System Settings Lost or Returning to Default Values

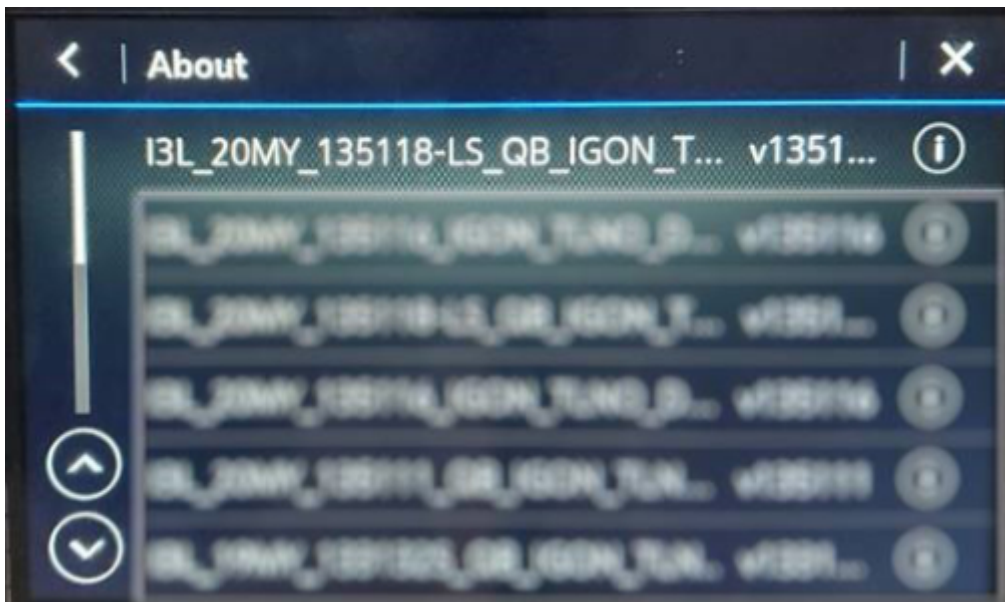
1. Verify the radio software version as this issue only pertains to version V135118. On the radio display, select Home, Settings, About. On this page will be what appears like a long file name. In the middle of this file name will be 135118.

- If the version is V135118 proceed to Step 2.
- If the version is numerically less than V135118 then this PI does not apply. Refer to SI for diagnostics.
- Tip: Before resetting the radio, please record the customer’s stored Favorites so that they can be re-entered afterward. Once selected it is important to wait for the radio to complete this process and reboot itself before the ignition is turned off.

2. Perform a radio reset by selecting “Erase settings and personal data” under the “Restore to factory settings.” Please document in the Warranty claim submission whether this was successful in preventing a loss of settings.
