Preliminary Information

PIT5834E A/C Blows Warm Intermittently Or Takes A Long Time To Start Cooling

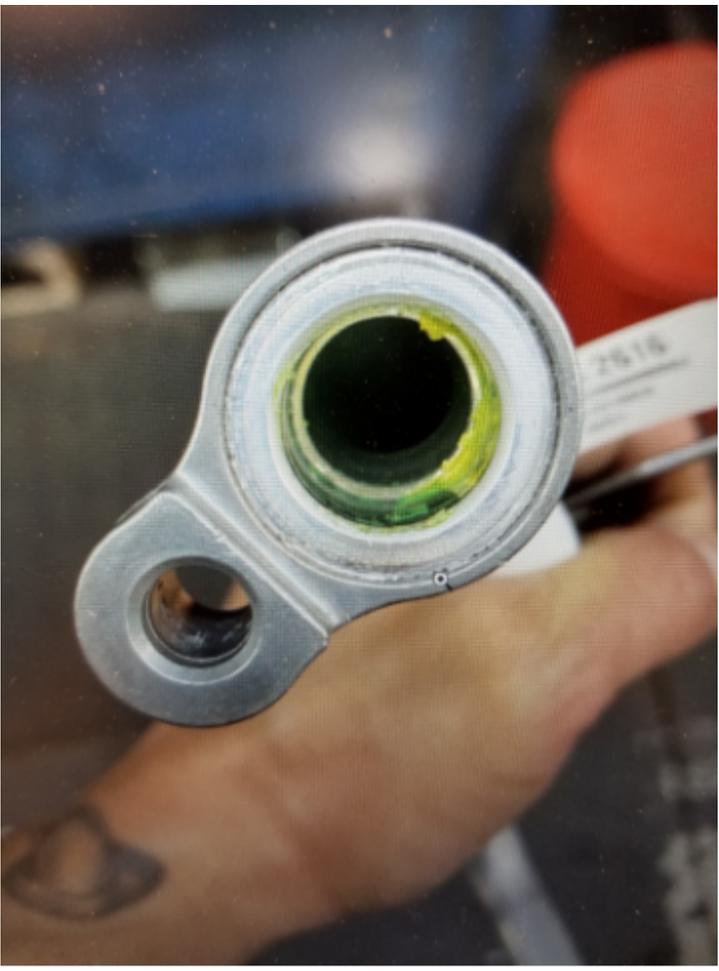
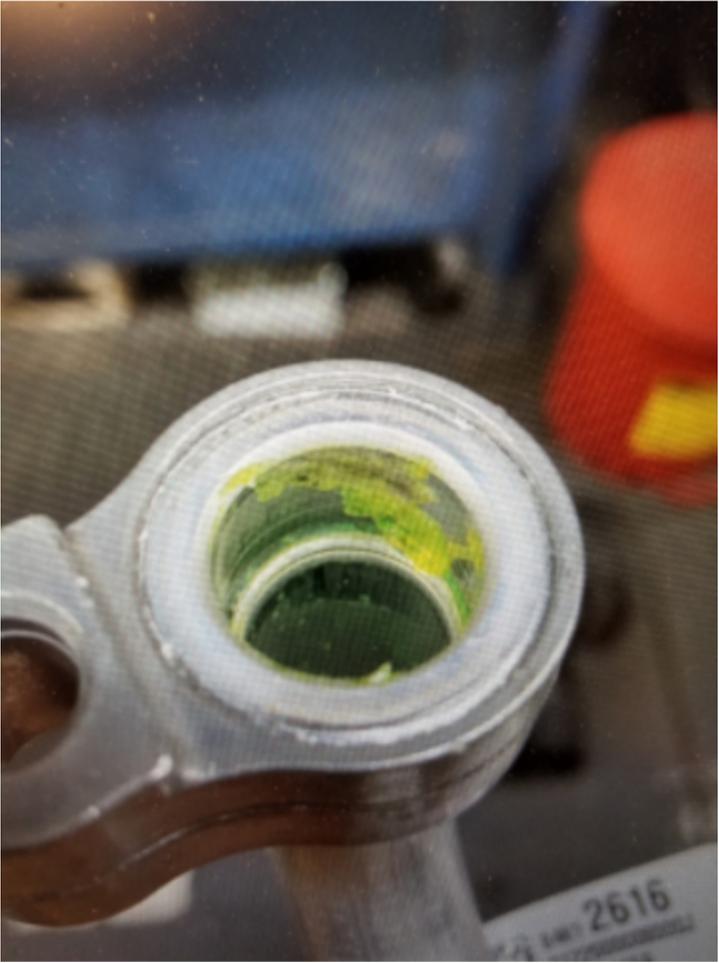
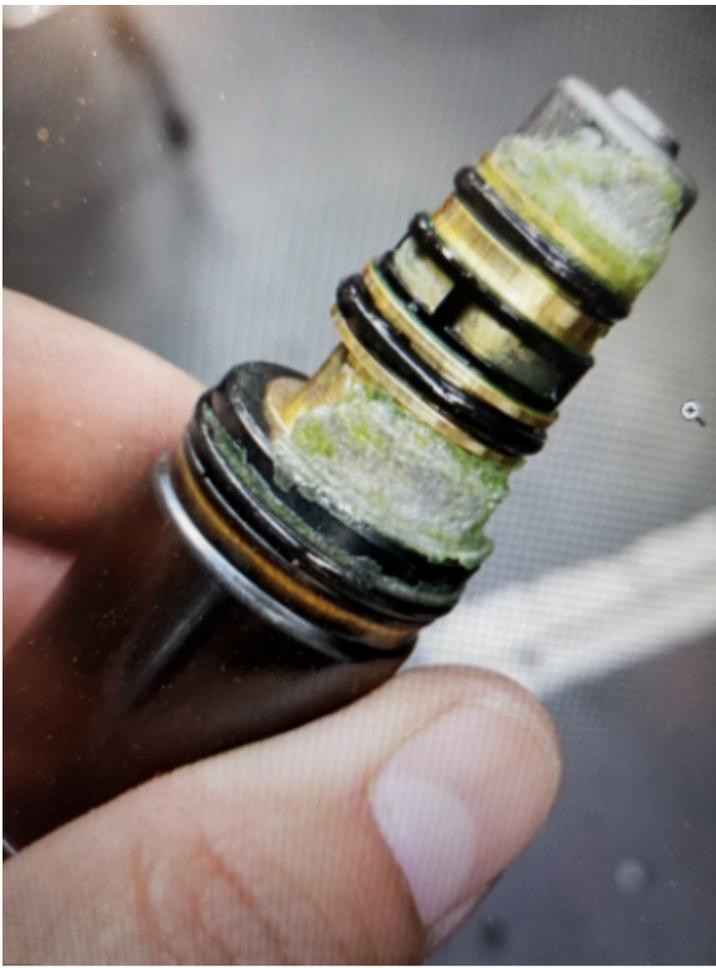
Involved Region or Country:	North America
Condition:	A/C is slow to cool, takes longer to blow cool air when compared to like vehicle or if the vehicles refrigerant needs to be evacuated for another repair.
Cause:	Possible A/C refrigerant contamination.

Remove the compressor solenoid, the inlet and outlet lines from the compressor and condenser and at the TXV.

Take pictures at each of these points and attach them to the case. (Pictures at ALL of these points are required for review.)
