# Preliminary Information

## PIP5819 VT40 Transmission Setting DTC P2714

Brand:	Model:	Model Years:	VIN:		Engine:	Transmissions:
			from	to		
Chevrolet	Malibu	2019 - 2021	All	All	All	VT40 CVT Automatic (MRG)
Chevrolet	Trailblazer	2020 - 2021	All	All	All	VT40 CVT Automatic (MRG)
Buick	Encore GX	2020 - 2021	All	All	All	VT40 CVT Automatic (MRG)

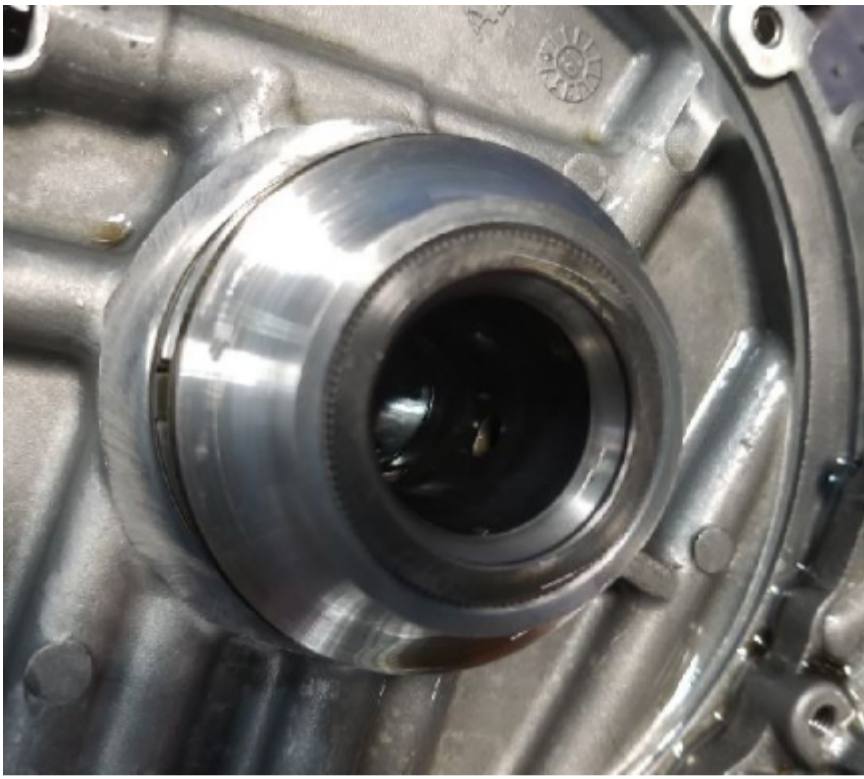
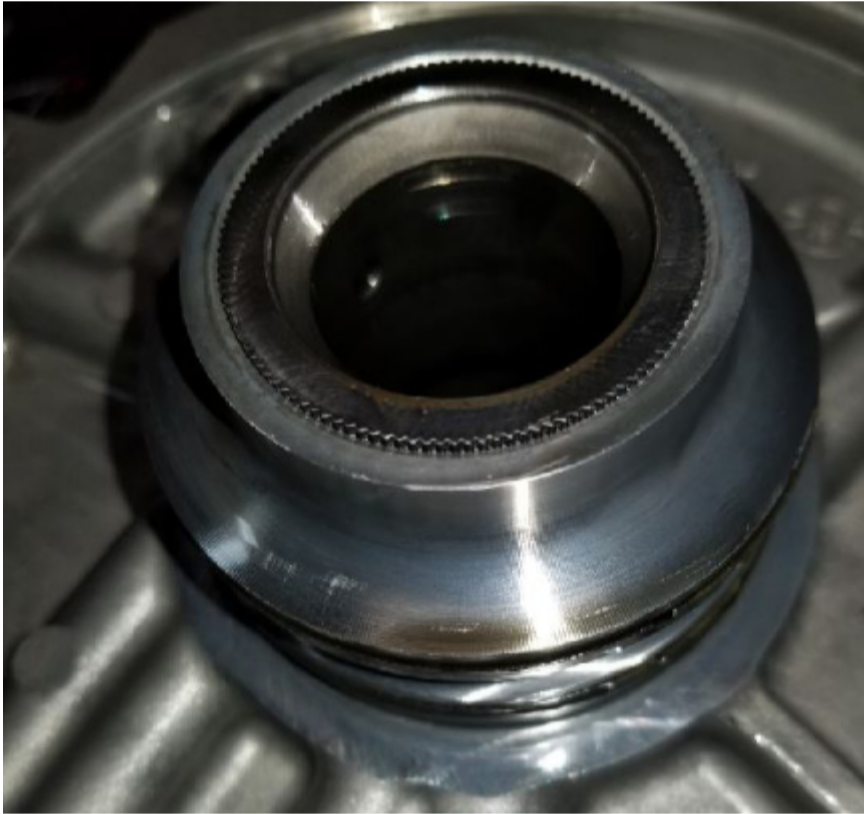
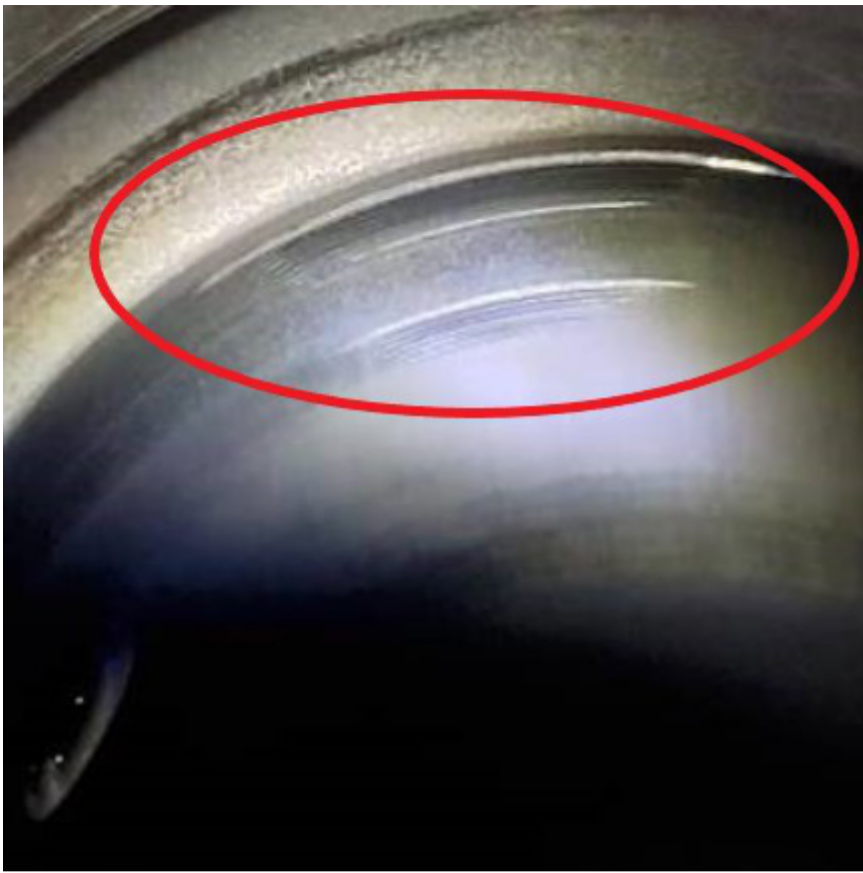
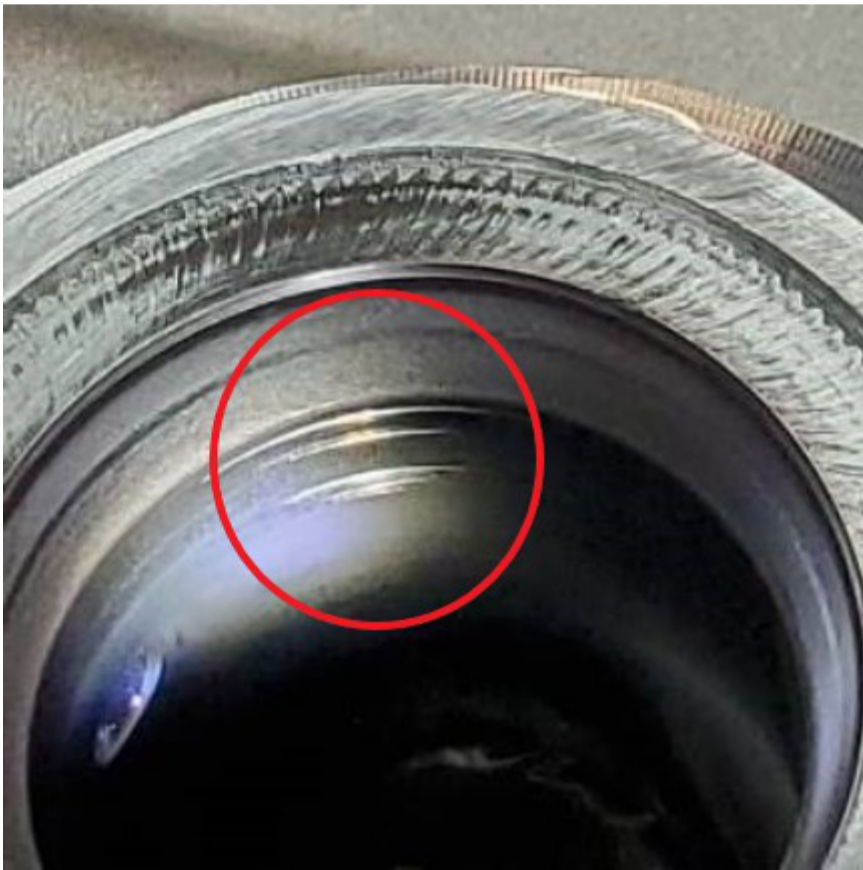
**Note:** The first 2 pictures show the outside of the pump, and the second 2 pictures show the wear that is found internal to the pump when wear to the Primary Pulley Bearing Bore is found .

If signs of wear are seen as shown, this indicates the Primary Pulley Bearing has spun in the bore and is allowing the Turbine Shaft to become off center. When this happens, it causes a pressure leak.

If this concern is found, the transmission will need to be replaced.
