TECHNICAL INSTRUCTIONS

SPECIAL SERVICE CAMPAIGN 21TC04

Incorrect Programming for Rear Seat Belt Reminder Indicator

CERTAIN 2021 Model Year C-HR

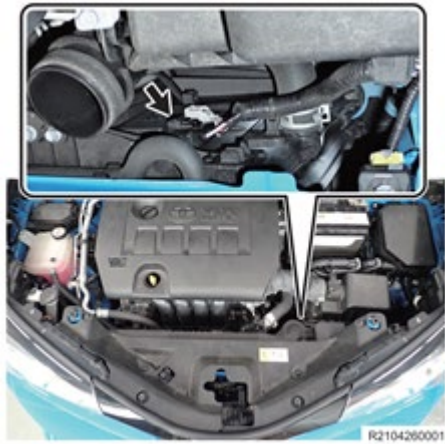
4. DISCONNECT COOLING FAN

If the cooling fans run during the Calibration update procedure, the battery voltage will be inconsistent and could cause damage to the control module(s).

a. Disconnect the electrical connector from the cooling fan ECU on the radiator fan shroud.
