2022 Sequoia Pre-Delivery Service (PDS)

Section Pre-Delivery Service

This bulletin contains the PDS procedures that apply specifically to 2022 model year Sequoia vehicles. A universal PDS [Check Sheet](#) that contains PDS steps that apply to all 2022 model year Toyota vehicles has been developed. To properly perform a complete PDS, you must complete all procedures contained in this TSB as well as the universal PDS [Check Sheet](#).

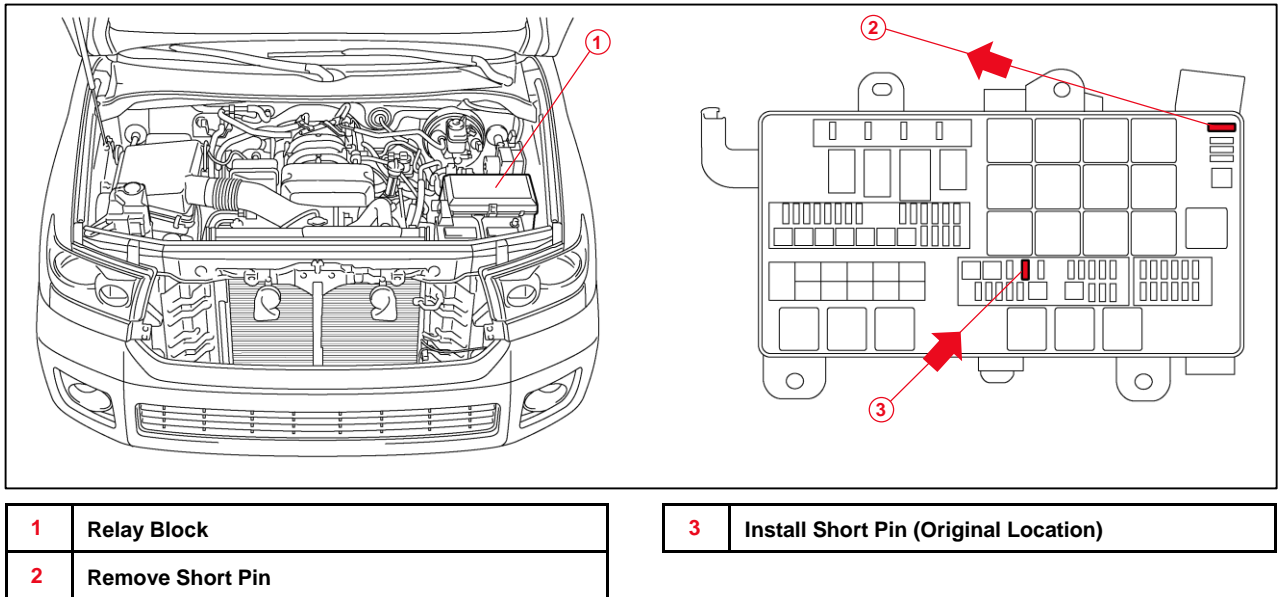
Figure 1.

The short pin has been removed at the assembly plant to reduce parasitic current draw in transit and storage. The removed short pin is stored in the blank space of the relay block in the engine compartment. The short pin **MUST** be reinstalled to the original location during PDS.

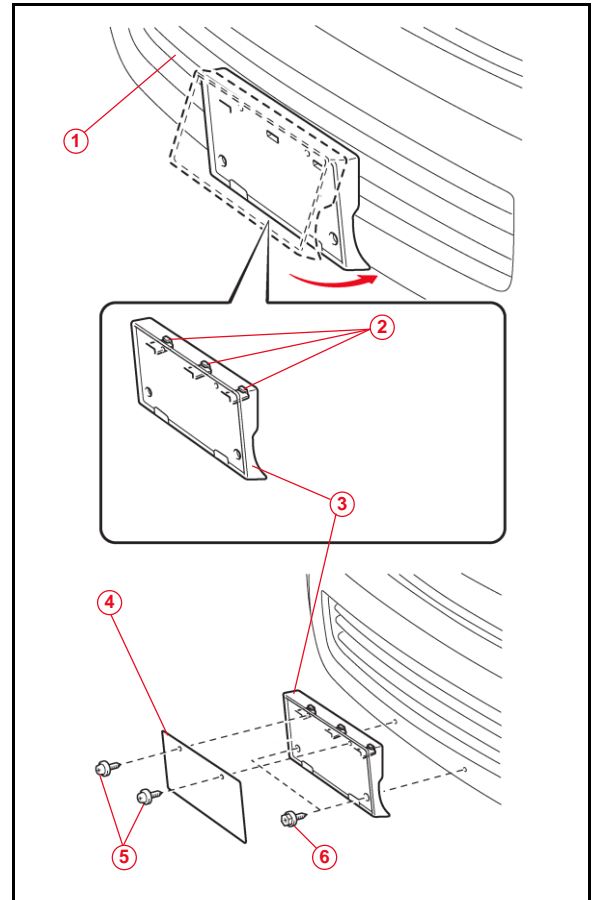
Figure 2.

The license plate bracket overlaps the radar sensor cover approximately 1.75 in. (45 mm).

1. Using a size 5/32 drill bit, drill holes into the dimple marks on the front bumper.
2. Attach the front license plate mounting bracket hooks to the air intake section of the front bumper.

3. Align the holes in the front license plate mounting bracket with the drilled holes on the front bumper.
4. Install two screws (screw A in Figure 2) through the bracket securing the front license plate mounting bracket to the front bumper.
5. Install two self-tapping screws through the license plate holes extending into the bracket.
