AUGUST 2021

**Re: Drag Specialties Alternator Rotor Part Number 2112-0333**

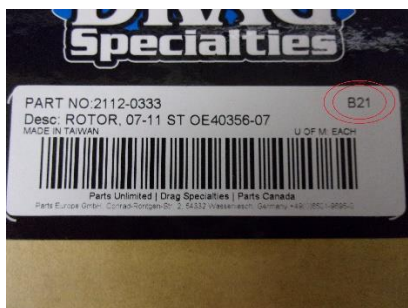
It has been brought to our attention that some inventory of a recent shipment of alternator rotor 2112-0333 may not have been properly magnetized. As a result, the alternator AC output may be lower than specified causing a dead battery. Rotors in this condition were shipped by LeMans to dealers between May 18 and July 15, 2021.

Our records indicate your account purchased this rotor during this time period. To identify potentially affected product, look at the package bar code label for the date code. Items with a date code of "B21" or "C21" should be returned. See the sample photo below:

If you still have this rotor in your possession, please return it to us for disposition. Contact Customer Service by phone at (800) 369-1000 or by email at [magraves@parts-unltd.com](mailto:magraves@parts-unltd.com) for instructions on how to return any affected inventory.
