<b>HYUNDAI</b> <b>Technical Service Bulletin</b>	<b>GROUP</b> <b>AUTOMATIC TRANSMISSION</b>	<b>NUMBER</b> <b>21-AT-013H</b>
	<b>DATE</b> <b>August, 2020</b>	<b>MODEL(S)</b> <b>ELANTRA SPORT (AD) 1.6T</b> <b>VELOSTER (FS) 1.6T</b> <b>ELANTRA (ADa) 1.4T</b>
<b>SUBJECT:</b> DUAL CLUTCH TRANSMISSION CLUTCH REPLACEMENT AND TCU SOFTWARE UPDATE

This TSB supersedes 20-AT-021H to update model information, removing Tucson and Sonata.

**Description:** Certain vehicles (listed below) equipped with 7-speed Dual Clutch Transmission (DCT) may exhibit abnormal vibration at low speeds. This bulletin outlines the procedures for diagnosing and replacing the Double Clutch, including a Transmission Control Unit (TCU) software update.

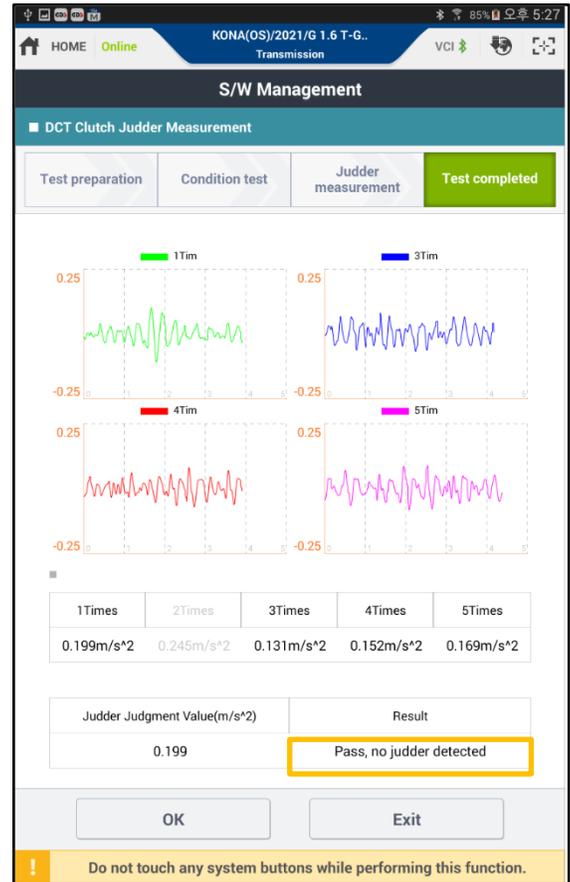
7. If the result is **“PASS, No Judder Detected”**, the service procedure is complete.

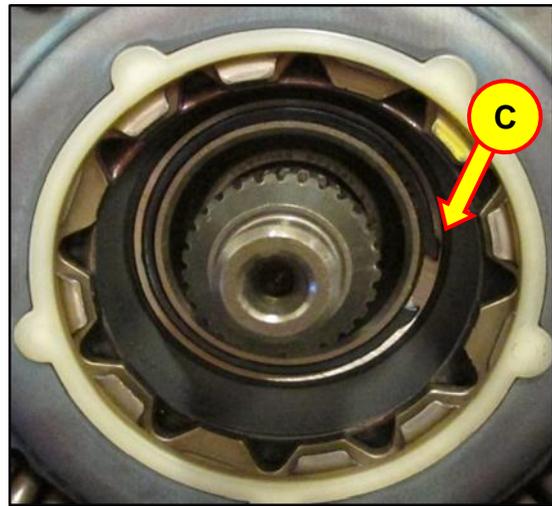
3. Remove the snap ring (C) (41068-2D000).

The snap ring can become deformed in the removal process. Do not reuse the existing snap rings when reinstalling the Double Clutch into the transmission.
