Technical Service Bulletin

43 Warning message in the cluster "Air suspension fault", DTC C11AFF0 is stored in the suspension module

43 21 55 2063660/2 September 7, 2021. Supersedes Technical Service Bulletin Group 43 number 21-49 dated June 14, 2021 for reasons listed below.

Model(s)	Year	VIN Range	Vehicle-Specific Equipment
A6, A7	2019	000001 - 015385	Adaptive suspension

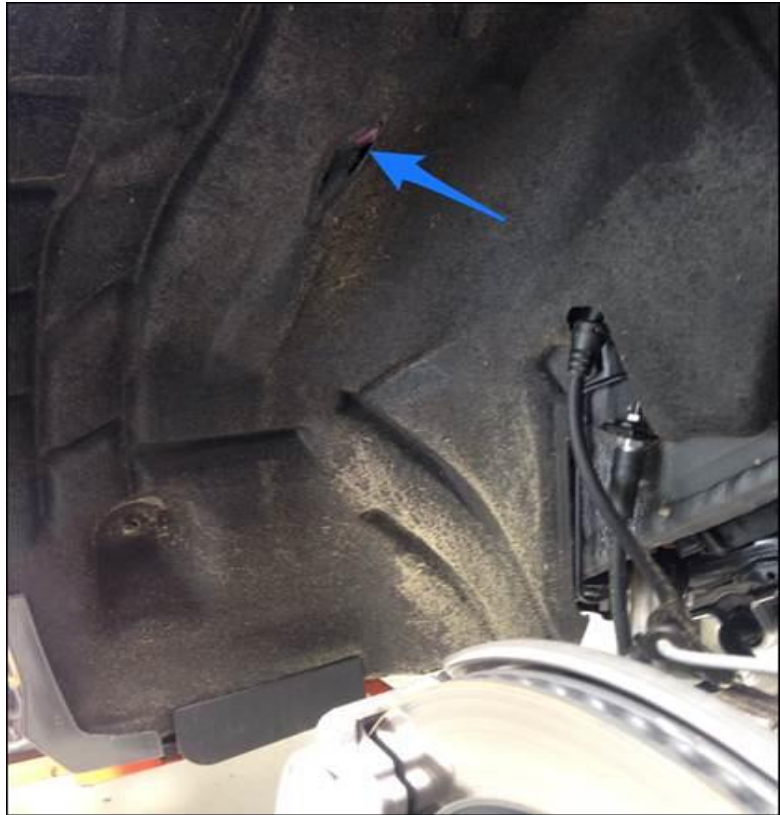
1. Check whether there are irregularities in the marked area of the rear left wheel housing liner (Figure 1).

Figure 1. Area of possible irregularities.

2. If there are irregularities in the marked area, follow steps 1 to 6 to correct the issue.
3. If there are **NO** irregularities in the marked area, perform diagnosis with GFF and tool VAS 751 001 to locate possible leaks/issues.

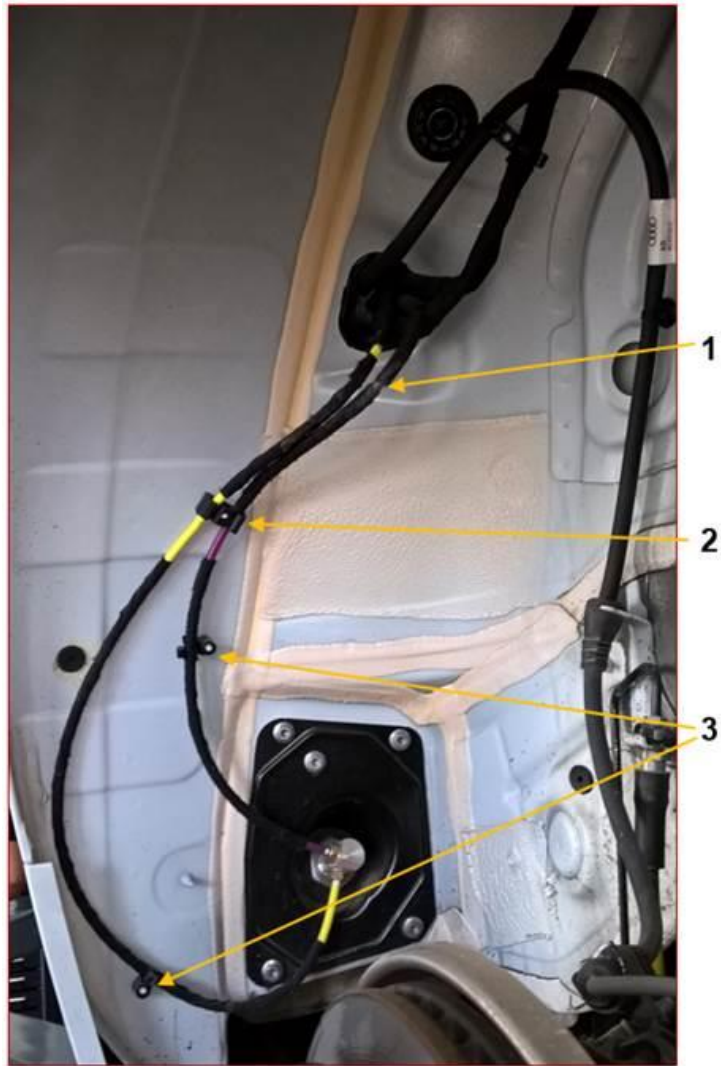
1. Check purple and yellow air hoses for damage (proceed with the repair, use only the repair kit set as described in ETKA) (Figure 2).

Figure 2. Area to be reworked.

2. Unclip both air hoses (Figure 2).
3. Loosen both cable ties (Figure 2).
4. Pull both air hoses down toward the accumulator and clip them in. Secure the hoses with a cable tie above the clip (the distance between the vehicle body and air hoses should be less than 35 mm) (Figure 3).

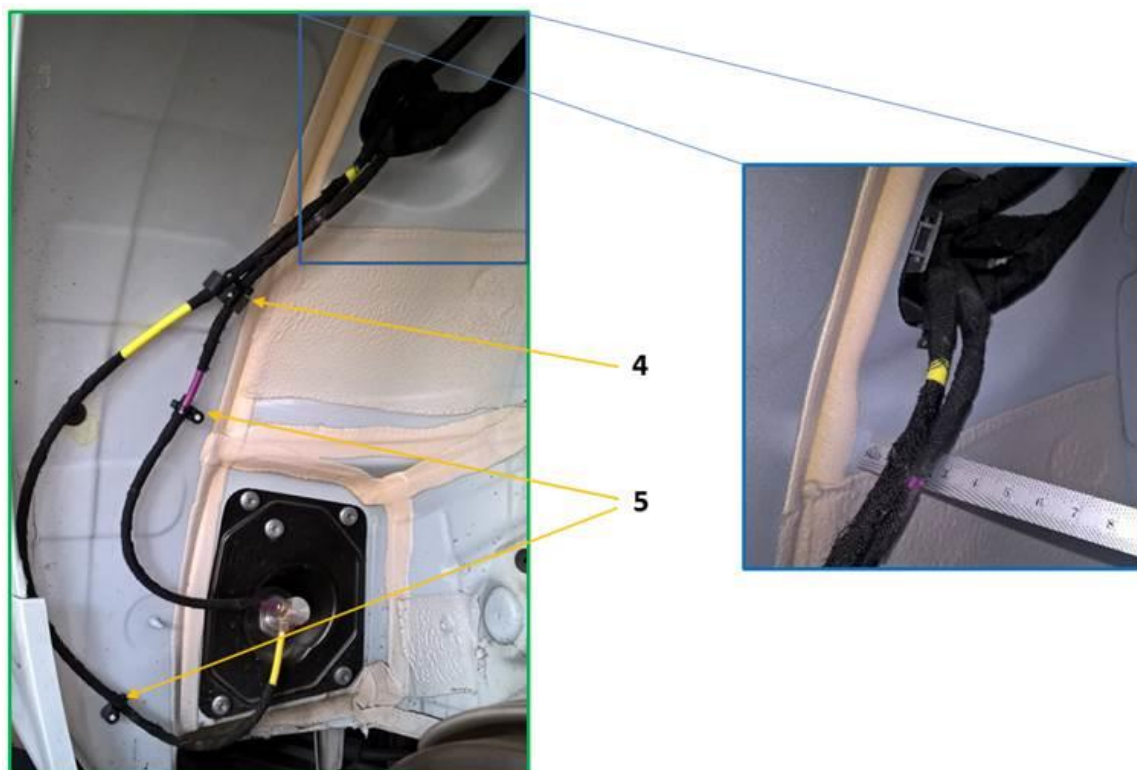
Figure 3. Close-up area: location where the distance between the vehicle body and air hoses should be less than 35 mm.

5. Secure the air hoses again at the intended locations with cable ties.
6. Replace the damaged wheel housing liner according to ETKA.
