Technical Service Bulletin

48 Steering column clicks when it is adjusted vertically

48 21 11 2064535/1 September 16, 2021.

Model(s)	Year	VIN Range	Vehicle-Specific Equipment
Q8	2019 - 2022	All	Not Applicable
Q7, SQ7	2017 - 2022	All	Not Applicable
SQ8, RS Q8	2020 - 2022	All	Not Applicable

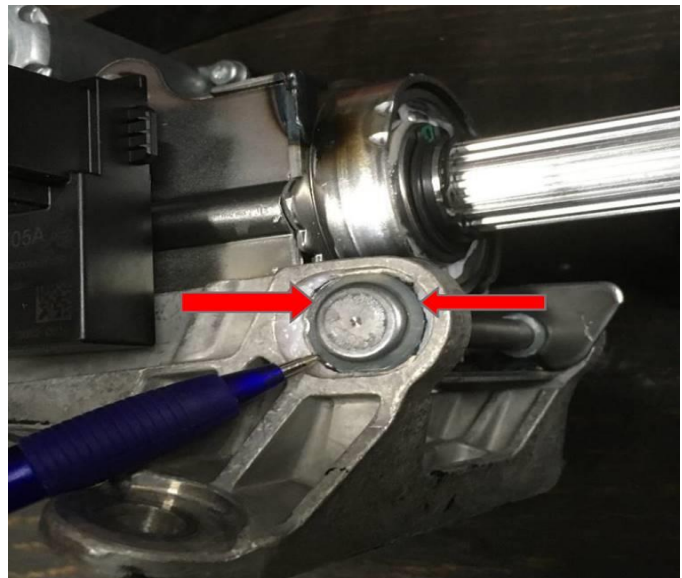
- Noises can be reproduced.
- The noise comes from the lower pin/hinge area of the steering column (Figure 1).

Figure 1. Lower pin/hinge – Steering column.

Steering column was assembled under tension.

Replace the bolts marked in the (Figure 2) according to the instructions in Elsa at Repair Manual, *Chassis >> 48 Steering >> Steering Column*.

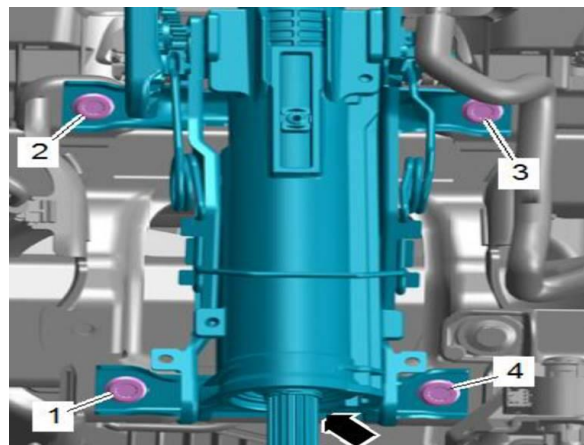
Figure 2. Steering column bolts.

- It is crucial to follow the tightening sequence and torque specification exactly.
- Use new bolts only.
