# Technical Service Bulletin

## 55 Power rear lid not closing fully, rear lid lock not engaging secondary latching position, DTC B113E29

55 21 59 2064476/1 September 10, 2021.

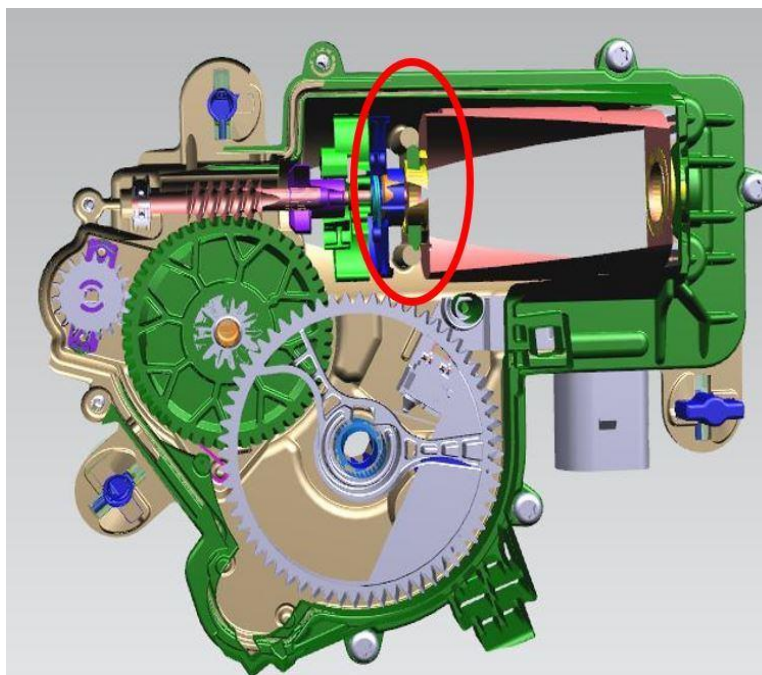
- 1 The internal clutch of the closing assist motor can be blocked due to a dimensional deviation (Figure 1).

**Figure 1.** Blocked clutch due to a dimensional deviation.

Replace the rear lid closing assist motor according to the Elsa Repair Manual.

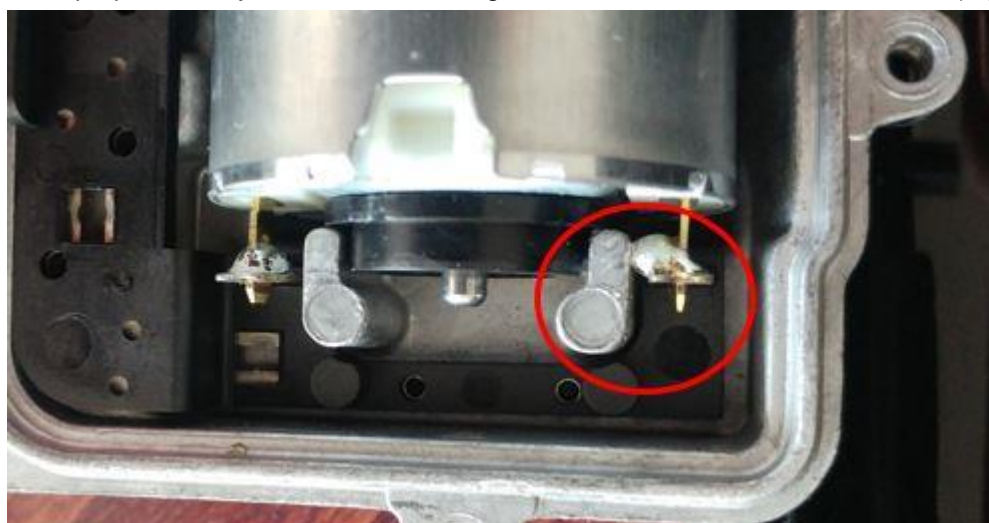
- 2 An improper solder joint inside the closing assist motor can cause a short circuit (Figure 2).

**Figure 2.** Short circuit caused by solder joint.

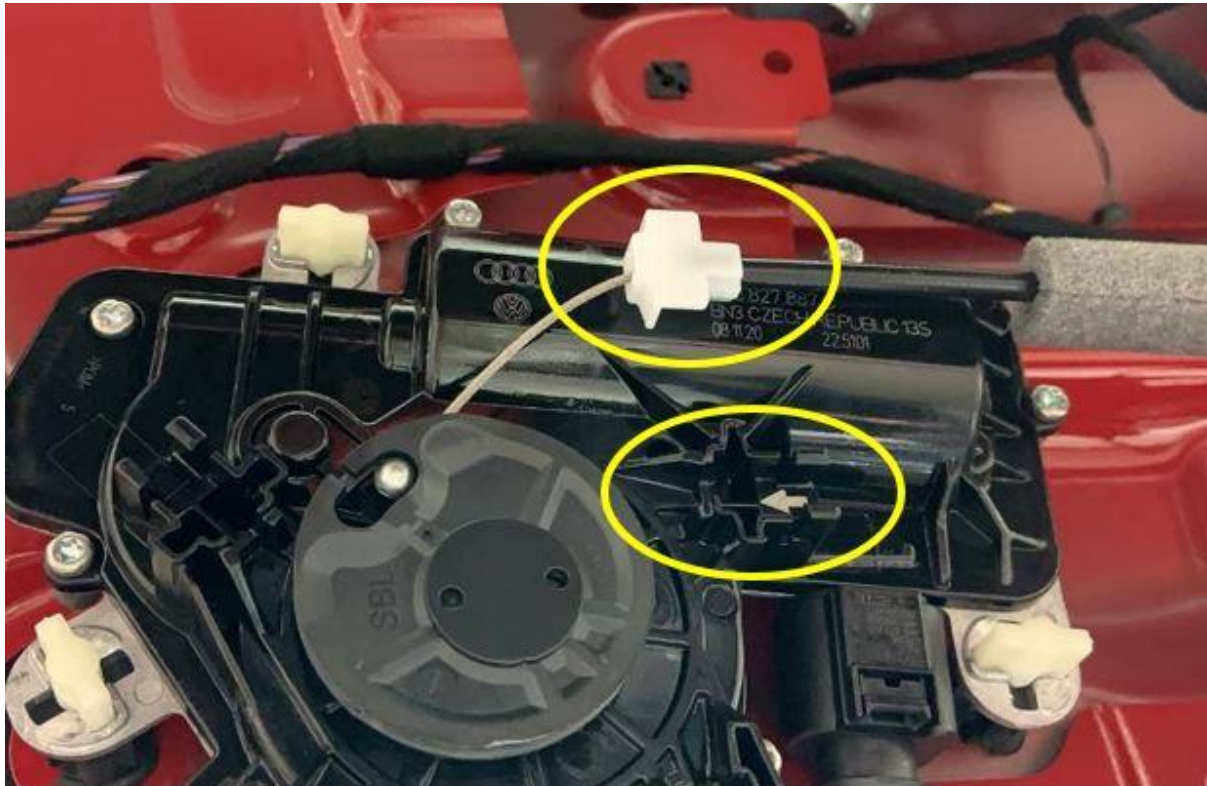
- 3 The Bowden cable clip has detached from the closing assist motor housing (Figure 3).

*Figure 3. Detached Bowden cable clip.*
