Technical Service Bulletin

94 Reverse lamp is inoperative, DTC(s) B12CB15 or B12CC15 stored in the comfort system control module

94 21 45 2063766/1 September 2, 2021.

Model(s)	Year	VIN Range	Vehicle-Specific Equipment
Q5, SQ5	2018 - 2020	All	Not Applicable
Q5 PHEV	2020	All	Not Applicable

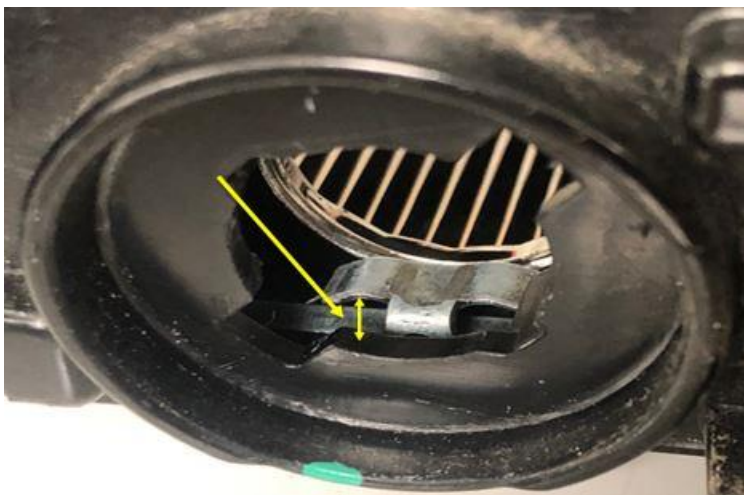
The internal circuit board for the reverse lamp (located in the lamps on the rear bumper) may become separated from the tail lamp housing. When this occurs the metal contact loses connection with the bulb socket.

Figure 1. Tail lamp contact loose/pulled away from housing.

1. If the bulb socket contact is loose/pulled away from the housing, the lamp will need to be replaced (Figure 1).

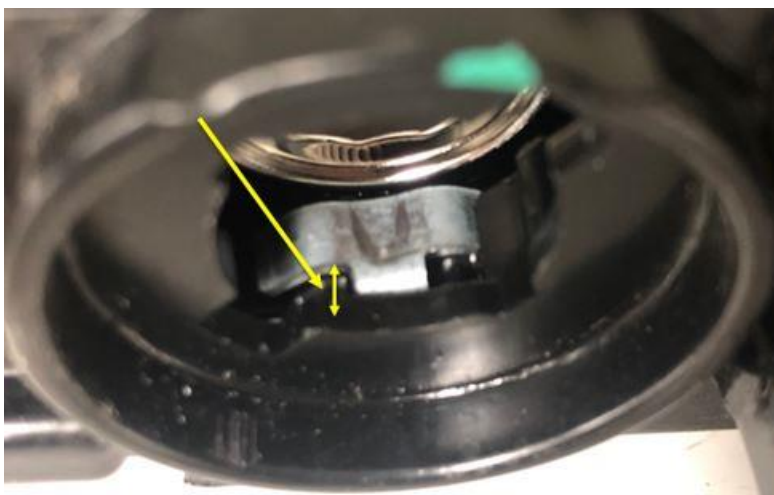
Figure 2. Lamp contact has separated from housing.

2. If the bulb socket contact is flush with the housing then no repair is needed (Figure 2).

Continue with normal diagnosis outside of this TSB.
