GROUP	MODEL
BOD	All Models
NUMBER	DATE
055 (Rev 1, 09/13/2021)	March 2010

TECHNICAL SERVICE BULLETIN

INFORMATION FOR HEADLAMP CONDENSATION AND MOISTURE

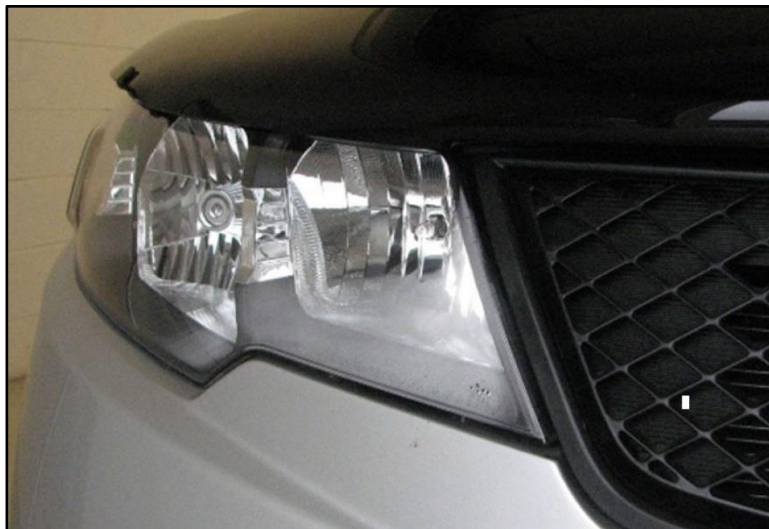
EXAMPLE: Moisture accumulated within the headlamp assembly displays a fogging condition.

Headlamp fogging (as shown above) is a normal occurrence and headlamp assembly replacement WILL NOT be necessary to resolve this issue.

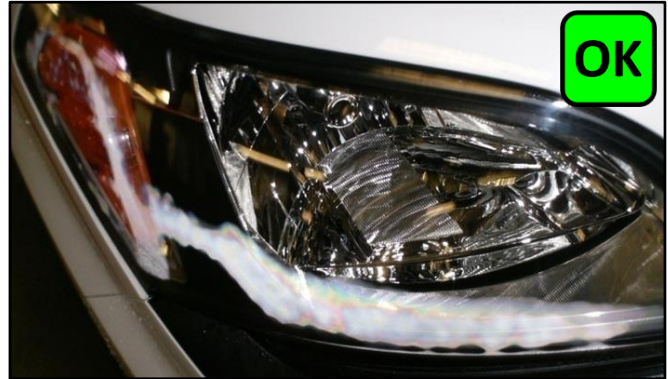
With a drop in air temperature, condensation droplets may form on the inside of the cool headlamp lens. This condition is **NORMAL** and can usually be eliminated by following the "Headlamp Assembly Drying Procedure" below. Repair or replacement is **not** required.

Example of normal condensation in headlamp.
No repair or replacement necessary.

Dry out the headlamp assembly by removing the dust cap(s) (A), then allow vehicle to idle for 30 minutes with engine running and headlamps turned **ON** in order for condensation/moisture to evaporate. Verify condensation has been eliminated.

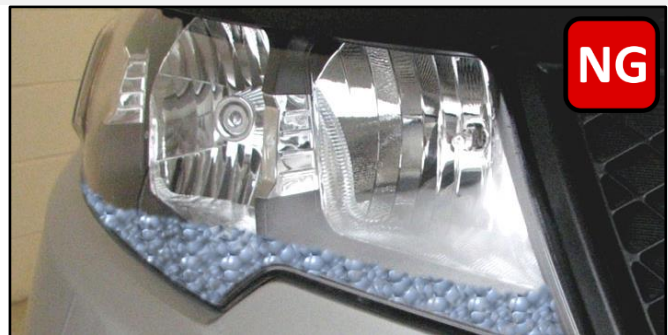
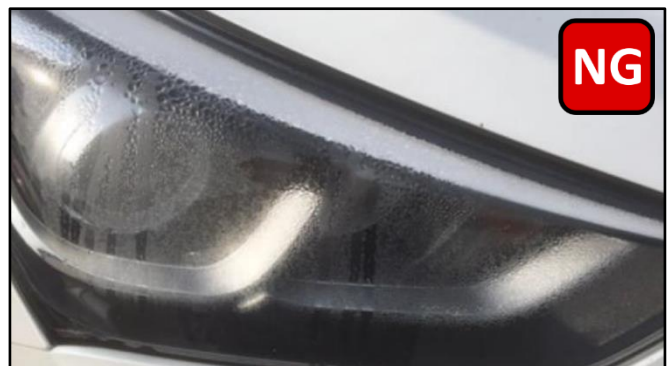
If water pools at the bottom of the headlamp assembly and/or if fogging remains after the "Headlamp Assembly Drying Procedure," this condition may be caused by a water leak. Water intrusion may be the result of a poor seal between the housing and lens or bulb socket, cracks in the headlamp assembly, poor fit, pressure washer, car wash, or other outside influence. In these cases, diagnose and repair as needed.

Examples of water leak in headlamp.
Water droplets inside of headlamp assembly.
Condition should be diagnosed and repaired.

Replacement of a headlamp assembly for an actual water leak requires DPSM approval and requires condition to be documented with photos attached to a TechLine case.

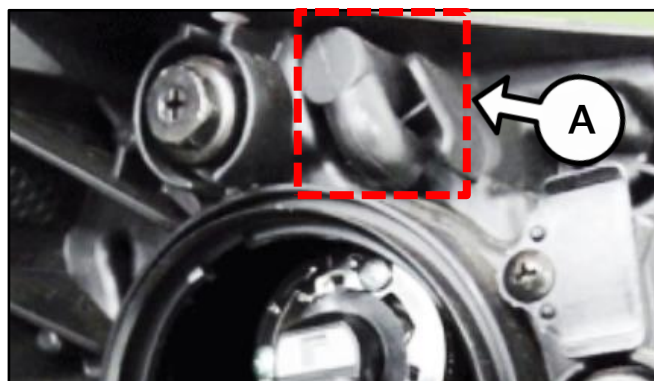
Blocked Headlamp Assembly Vents

Spider webs, dirt, debris, or other foreign substances may block headlamp assembly vents (A) and prevent normal ventilation.

Solution: Locate and inspect the headlamp assembly vents for blockage, and clean as needed.

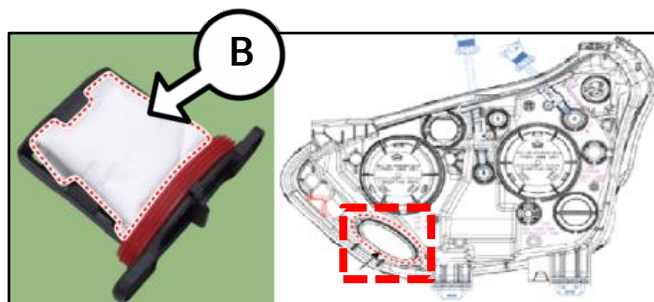
Desiccant Bag Over-saturation

The desiccant bag (B) has absorbed its maximum amount of moisture and is no longer effective.

Solution: Locate and replace the over-saturated desiccant bag.

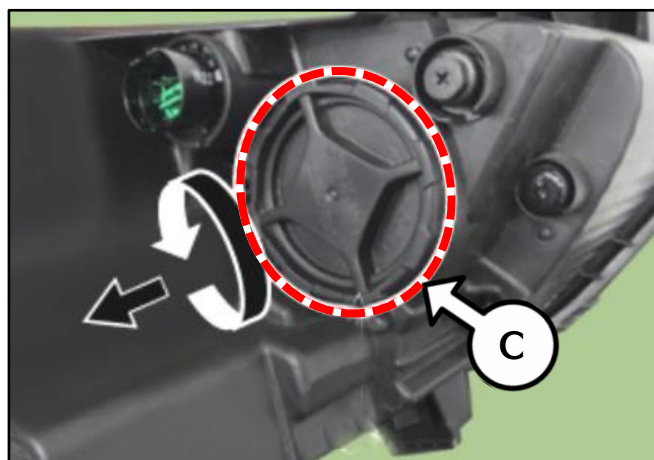
Failed Headlamp Assembly Seals or Gaskets

Seals or gaskets (C) may be damaged by minor accidents, incorrectly installed bulbs, shipping damage, pressure washing, or certain car washes.

Solution: Locate the area of failure and determine if it is repairable. In some cases, headlamp replacement will be necessary.

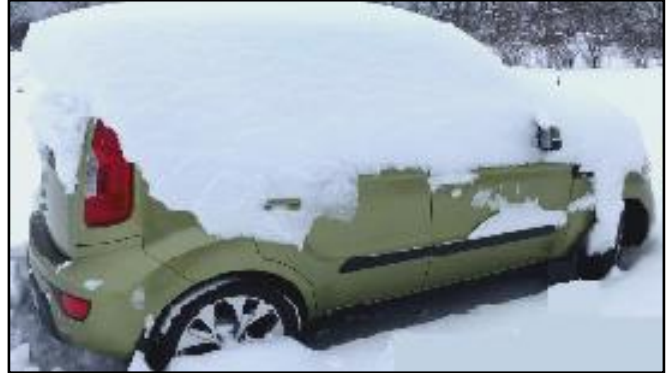
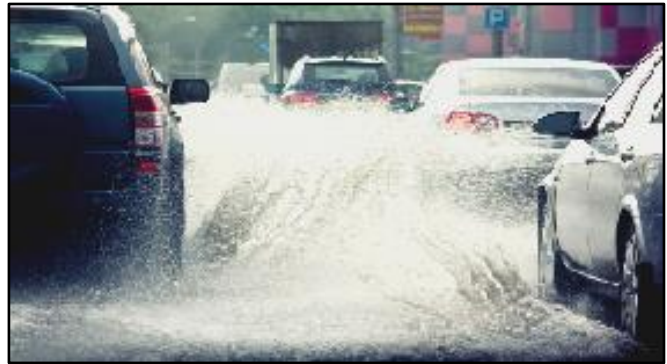
Extreme weather and elements such as wind, water, dirt, debris, heat, freezing, or other foreign influences may cause water intrusion into the headlamp assembly.

Solution: Perform the "Headlamp Assembly Drying Procedure" on page 2 to eliminate moisture. If moisture cannot be eliminated, perform further diagnosis per this TSB and KGIS.

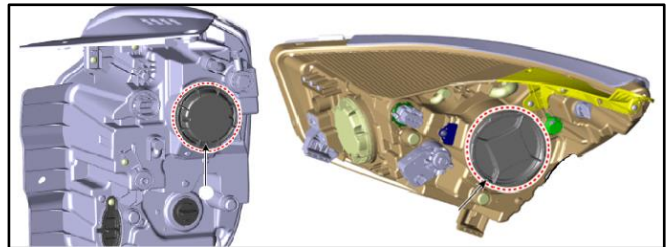
**Model Specific Differences**

Certain models may have different headlamp assembly designs which allow more moisture and condensation to collect than others.

Solution: Search KGIS for model-specific TSBs, Service Actions, or Campaigns available for these models/headlamp assembly designs.
