94-21-01 - LED Center Tail Light Assembly Deflecting Away from Body

Release date: 9/22/2021

Applicable Vehicles					
Model(s)	Year	Eng. Code	Trans. Code	VIN Range From	VIN Range To
ID.4	2021	All	All	All	All

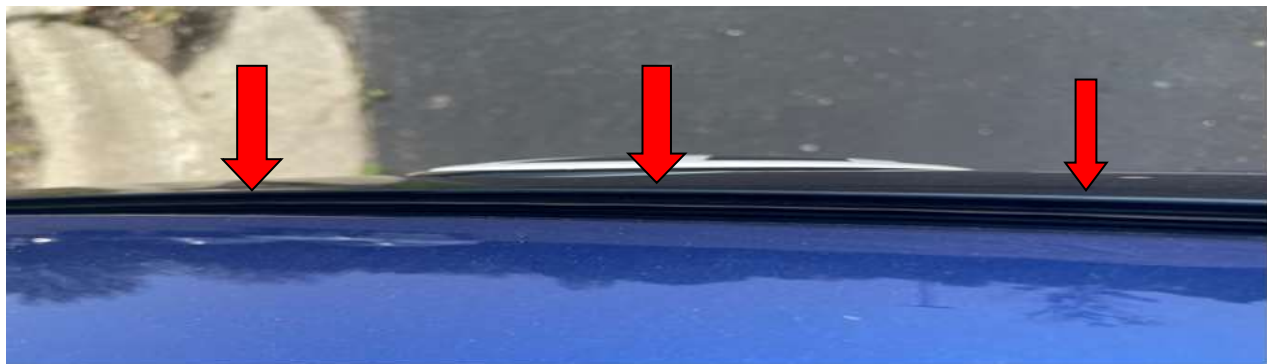
Figure 1

LED tail light assembly deflecting away from the rear lid outwards due to temperature fluctuations.

The LED tail light cluster is bolted to the rear lid on the left and right. The LED tail light cluster arches in the center outwards with a significant temperature change. As a result the LED tail light cluster is pushed out of its middle attachment clip and a gap between the rear lid and continuous LED tail light cluster is created. Figure 1.

Apply Lithium grease (G 052 150 A2) or equivalent to the mounting points and install updated securing mountings (11A 945 179 A) or later suffix.
