Technical Service Bulletin

50 Creaking noises heard when body twists during braking or steering maneuvers

50 21 08 2061672/2 September 22, 2021. Supersedes Technical Service Bulletin Group 50 number 20-03 dated December 16, 2020 for reasons listed below.

Model(s)	Year	VIN Range	Vehicle-Specific Equipment
A6, A7	2019 - 2021	All	Not Applicable
A6 allroad, S6, S7, and RS 7	2020 - 2021	All	Not Applicable
RS 6 Avant	2021	All	Not Applicable

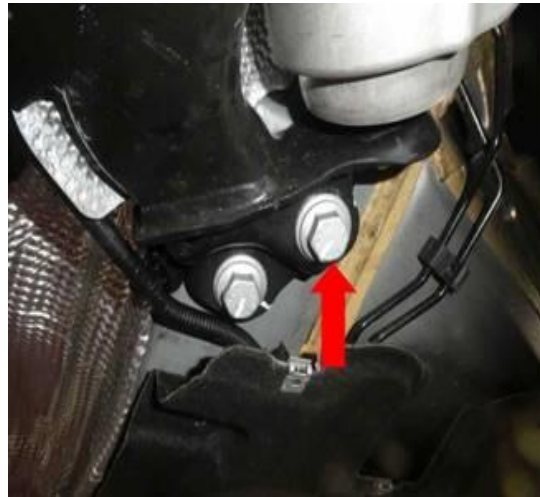
Figure 1. Front most bolt on subframe to be loosened.

1. Duplicate the noise on a test drive preferably with the customer so that the conditions under which this symptom presents are clearly identified. If this noise is duplicated on the test drive confirmation that the source of the noise is from the longitudinal member and that the repair described in this TSB will be effective can be achieved as follows.
2. Begin your diagnosis by loosening the front most bolt on the subframe mounting as indicated in Figure 1. The bolt only needs to be loosened several turns but not removed.

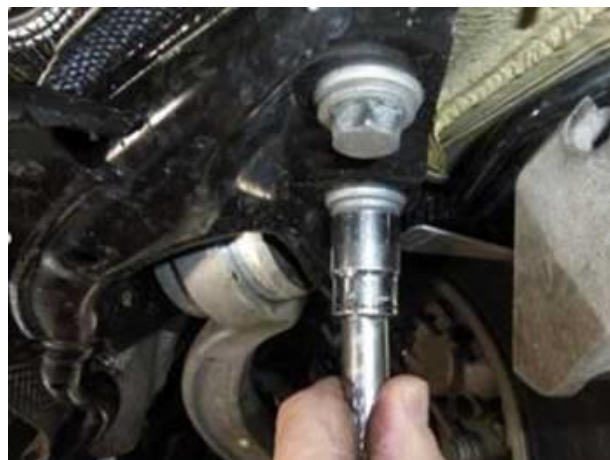
3. In many cases an audible 'cracking' noise can be heard in the course of loosening and tightening the subframe bolt (Figure 2).

Figure 2. Loosening the front most subframe bolt.

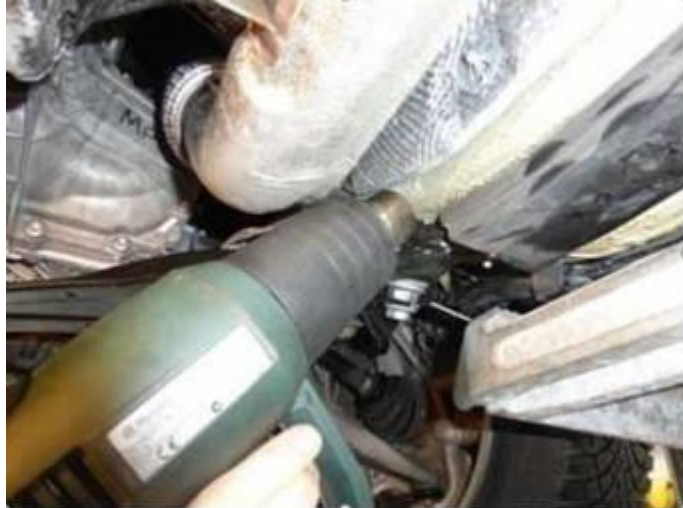
Figure 3. Warming the area of the body near the rear transverse link.

5. Duplication of this noise is difficult when the vehicle is cold. If you suspect that the cold is preventing duplication of this symptom warm up the longitudinal member/body in the area of the rear transverse link bolted connection with a hot air blower set for an outlet temp of approximately 550°C (1022 °F) (Figure 3).

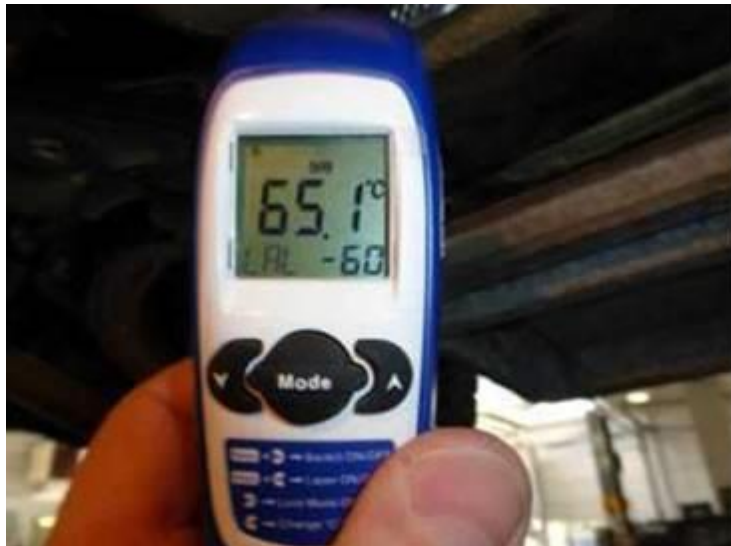
Figure 4. Surface temperature warmed to 65° C (149°F).

6. Warm the surface to approximately 65 °C (149°F) (Figure 4).

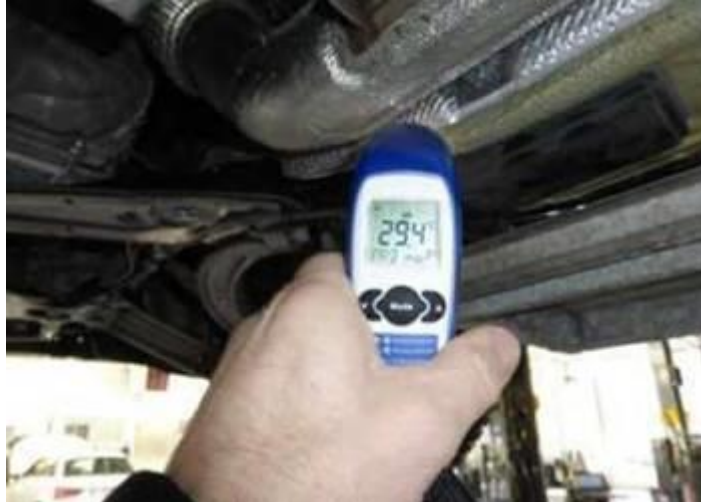
Figure 5. Surface temperature cooled to approximately 30° C (86°F).

7. Allow the surface temperature to cool to approximately 30 °C (86°F) then test drive the vehicle again.

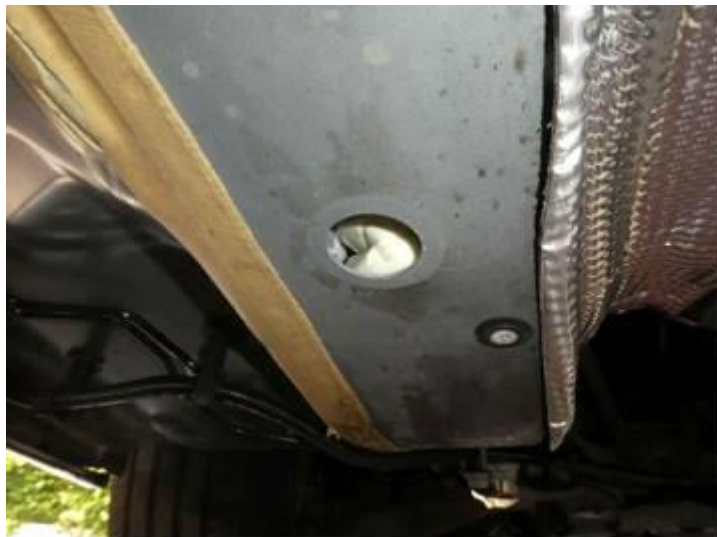
Figure 6. Body plug removed.

8. Merely lowering the vehicle from the hoist can immediately elicit the noise symptom after this warming process.
9. With the symptom confirmed, lower the center cover plate on the affected side. Remove the first body plug aft of the bolted connection for the transverse link (Figure 6).

Replace the body plug removed in this step with 8K0 805 267.

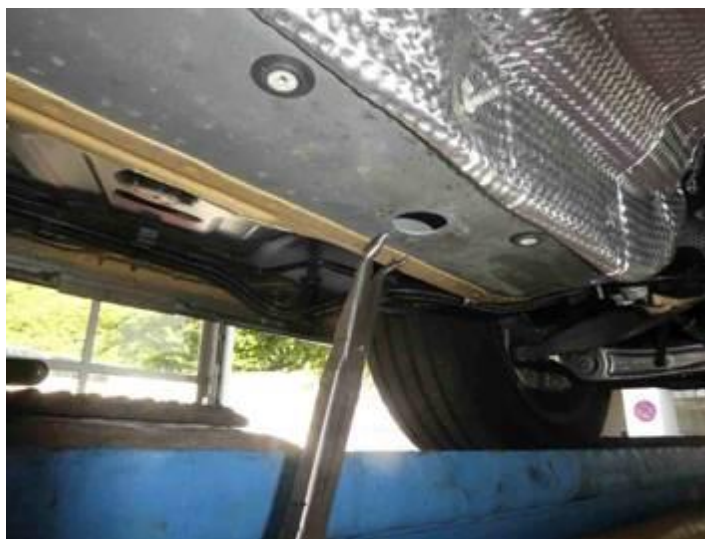
Figure 7. Remove a portion of the acoustic foam.

10. In order to provide appropriate access to the affected area inside the longitudinal member remove sections of the acoustic foam in the longitudinal member area with long needle nosed pliers. It is not necessary to remove all of the acoustic foam and the small amount removed for this procedure will not need to be replaced (Figure 7).

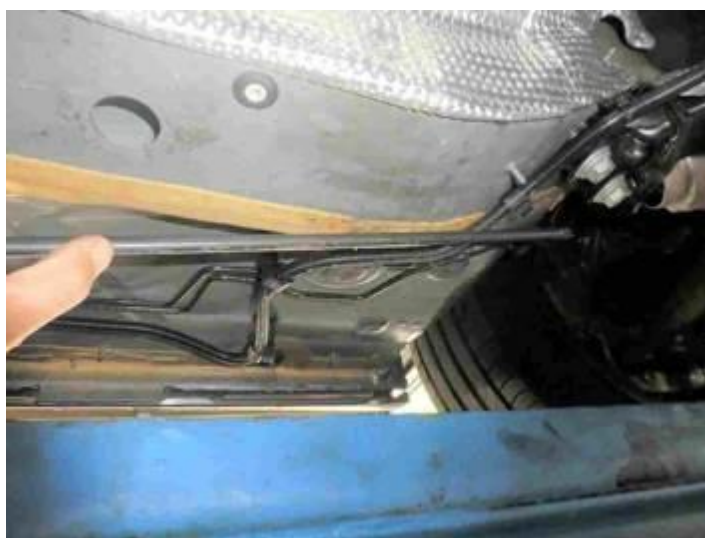
Figure 8. Tool to be fabricated.

11. An improvised tool for this modification will be fabricated. Obtain a steel rod 8mm in diameter and 60 cm long (Figure 8).

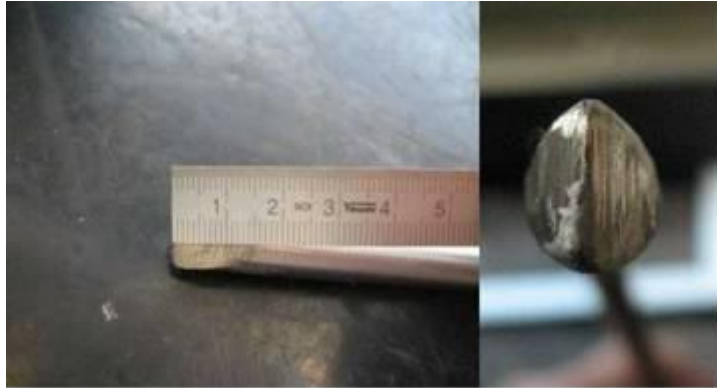
Figure 9. Grind the tip of the steel rod.

12. Grind the tip of one end of the rod into a chisel shape. The length of the grind should be 15mm +/-3mm on each side as shown in Figure 9.

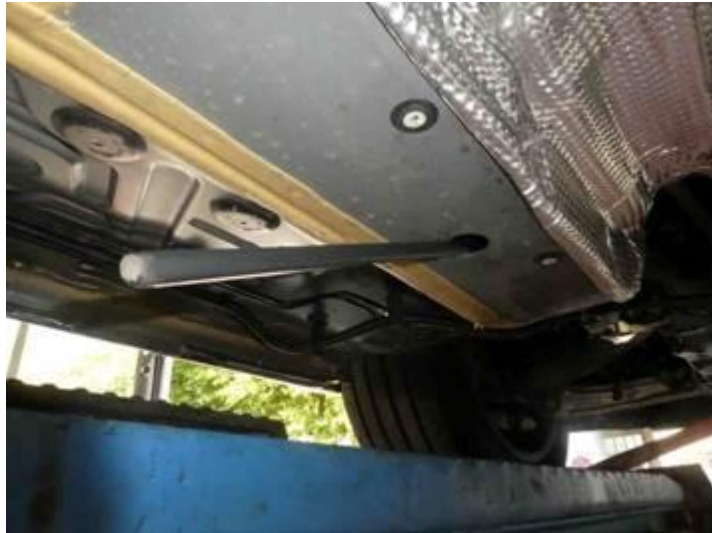
Figure 10. Insert the steel rod.

13. Insert the chisel end of the steel rod into the body opening, through the remaining acoustic foam and far enough to engage the longitudinal member support (Figure 10).

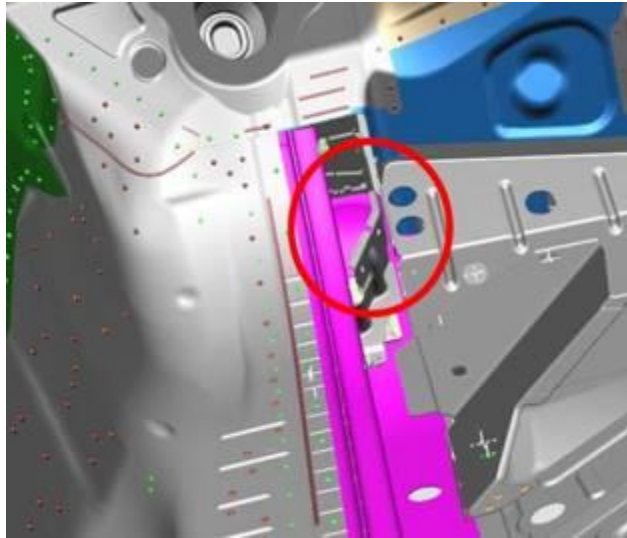
During a cornering or hard braking maneuver the longitudinal members can make contact with their internal support plates.

14. The drawing in Figure 11 shows a cut-away of the area where the longitudinal member support and the longitudinal member housing make contact.

Figure 11. Cut-away drawing of the inside of the longitudinal member.

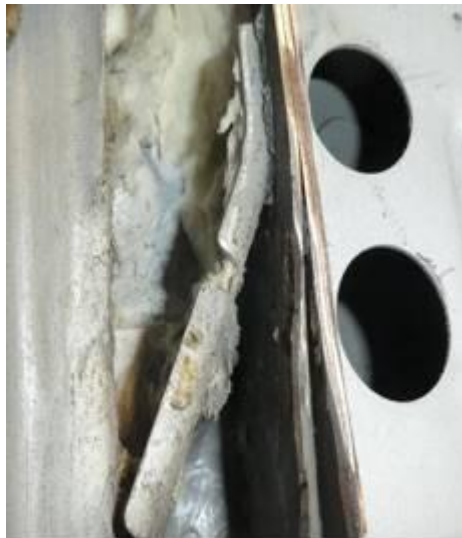
15. Figure 12 shows an opened longitudinal member and support.

Figure 12. Opened longitudinal member and support.

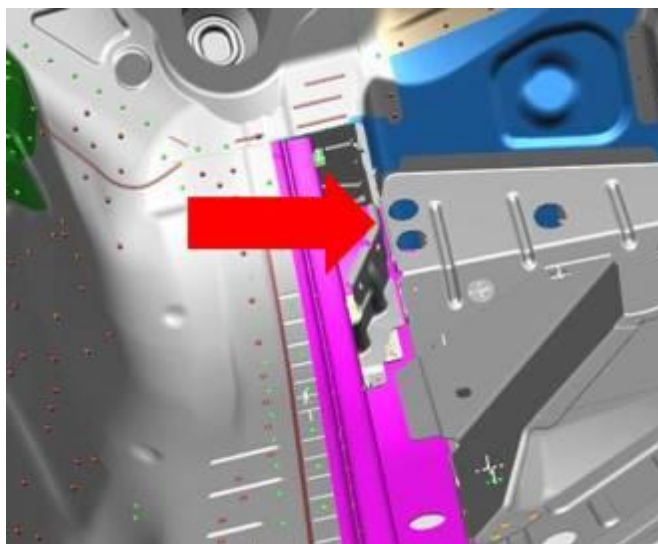
Figure 13. Point of contact for the steel rod.

16. Insert the steel rod to the point of contact indicated by the red arrow shown in Figure 13.

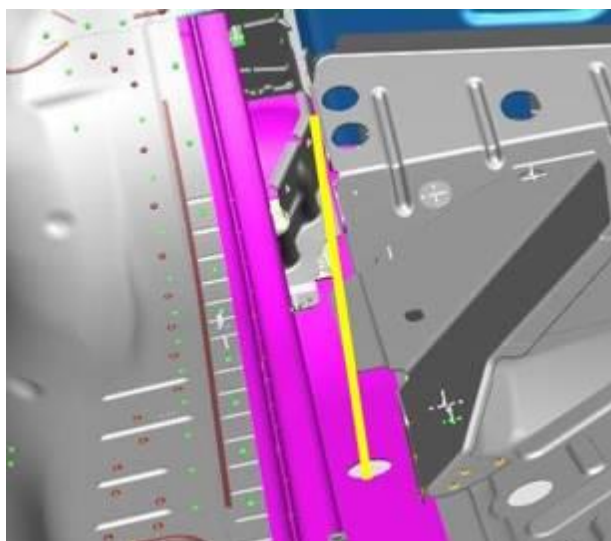
Figure 14. Direction of insertion of the steel rod.

17. The yellow line in Figure 14 shows the position the steel rod will realize after insertion and engagement with the longitudinal member support.

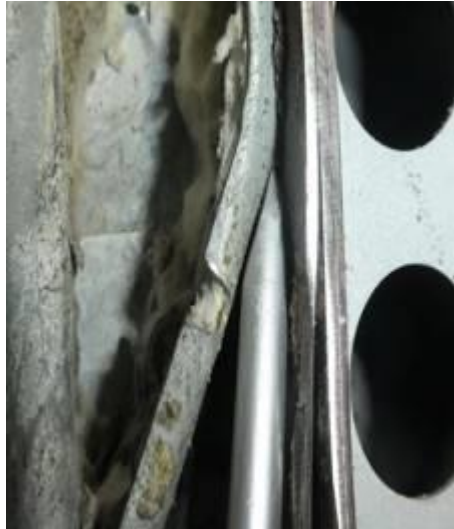
Figure 15. *Correct engagement of the chisel end of the steel rod.*

18. The chisel end of the steel rod must be inserted as shown in Figure 15 with the wedge engaged consistent with the space formed by the longitudinal member support to the longitudinal member housing.

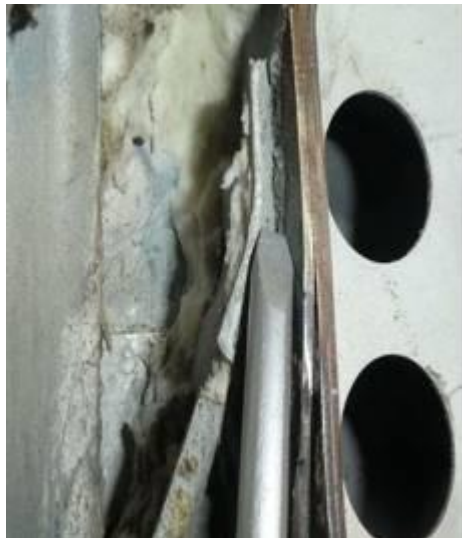
19. Figure 16 shows an incorrect engagement of the chisel end.

Figure 16. *Incorrect engagement of the chisel end.*

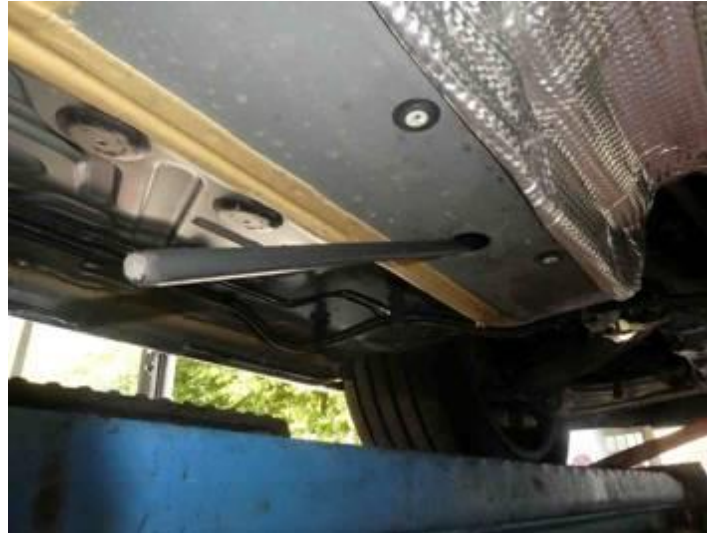
Figure 17. Driving the steel rod into the longitudinal member support.

20. Using a hammer drive the steel rod a distance of 4 – 5 cm. Ensure the correct distance measure and mark this distance on the steel rod with tape (Figure 17). Remove the tool when finished.
