# Technical Service Bulletin

## 94 Rear lights do not switch from bumper to the hatchgate

94 21 48 2047618/5 September 22, 2021. Supersedes Technical Service Bulletin Group 94 number 20-23 dated April 20, 2020 for reasons listed below.

Model(s)	Year	VIN Range	Vehicle-Specific Equipment
Q7, SQ7	2017 - 2023	All	Not Applicable

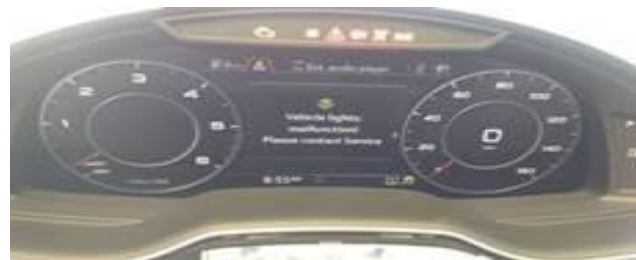
- When the rear lid is closed, the lights in the rear bumper do not switch over to the main lights on the rear lid.
- The error message “Vehicle lights: malfunction! Please contact Service” intermittently appears in the driver information system (Figure 1).
- All of the rear light bulbs are fully functional. None are found to be faulty or incorrect.

**Figure 1.** Error message.

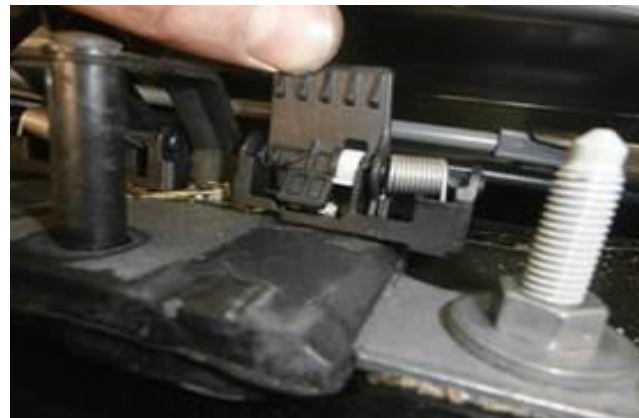
Mounted to the base of the rear lid striker is the G525/G526 rear lid closed sensor. Due to its position, debris that enters the striker housing can get caught in the switch mechanism and cause incomplete switch actuation (Figure 3).

*Figure 3. Debris in the rear lid closed sensor.*

2. If debris is found to be obstructing proper switch activation/deactivation, activate the switch paddles using your fingers and remove the debris. Using compressed air is effective.  
Then check the measuring values for the G525 and G526 switches and replace the rear lid closed sensor, if the malfunction persists. Only the improved rear lid closed sensor with the protective enclosure is available.

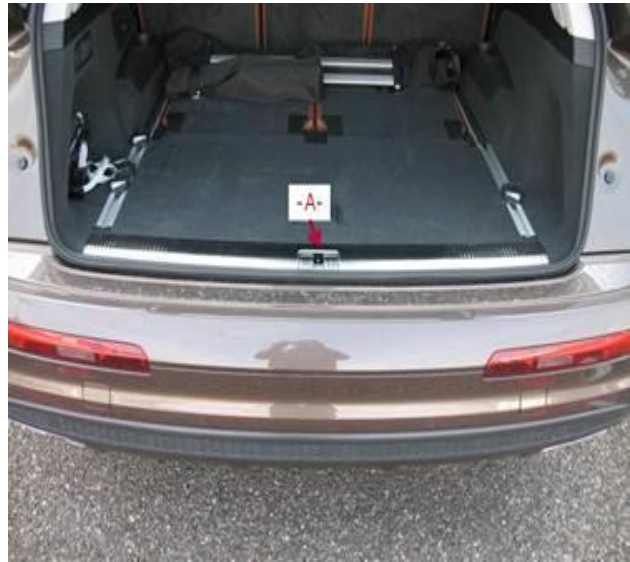
*Figure 4. Striker cover opening.*

1. Press down the striker cover on the loading sill cover -A- (Figure 4).

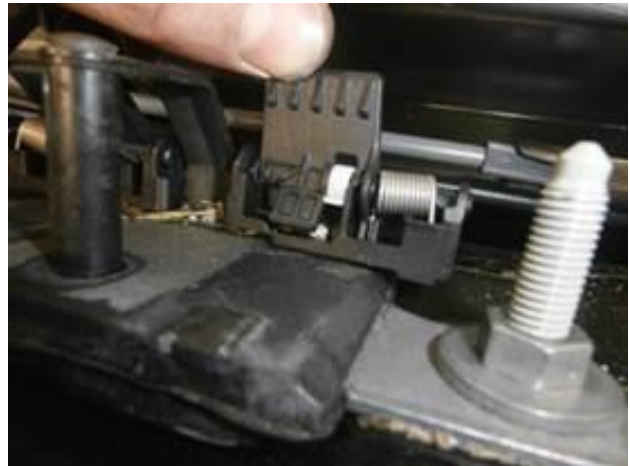
*Figure 5. Debris trapped in the rear lid closed sensor.*
