GROUP	MODEL
Engine	2017-2022MY Niro HEV (DE HEV) 2018-2022MY Niro PHEV (DE PHEV)
NUMBER	DATE
PS709	September 2021

ENGINE OVERHEATING IN NIRO HEV/PHEV

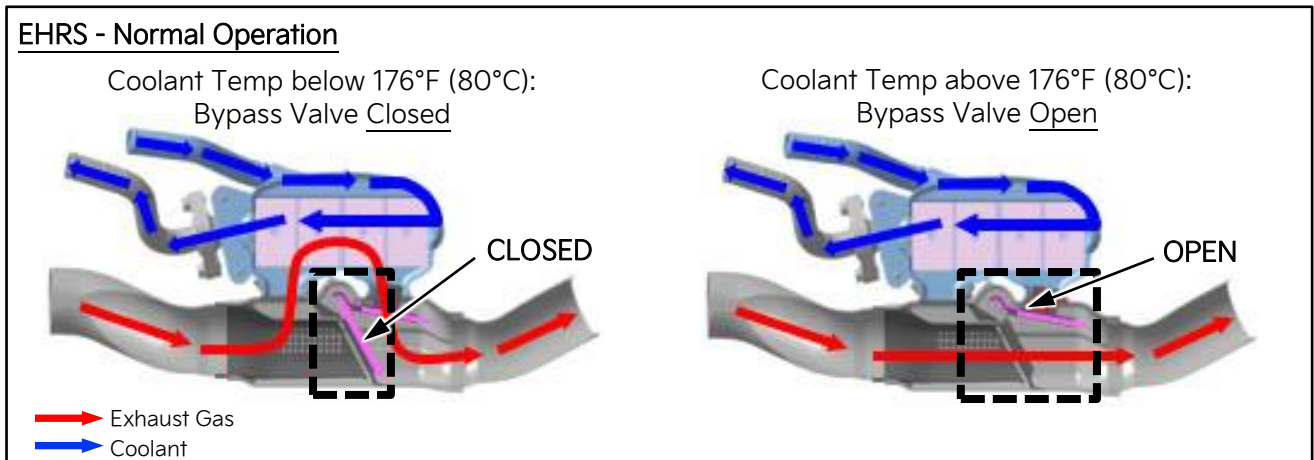
This Pitstop provides information to help troubleshoot an overheating symptom on some 2017-2022MY Niro HEV (DE HEV) and 2018-2022MY Niro PHEV (DE PHEV) which may exhibit coolant boiling in the reservoir. Overheating may occur due to a bypass valve in the Exhaust Heat Recovery System (EHRS) stuck in the closed position. A stuck closed bypass valve may cause exhaust gas to excessively heat up engine coolant in the heat exchanger. This valve normally opens above 176°F (80°C) allowing exhaust gases to bypass the heat exchanger once the engine is warmed up.

For vehicles exhibiting symptoms of overheating, test the Wax Actuator and Valve Lever by referring to the “Engine Mechanical System → Intake and Exhaust System → Exhaust Heat Recovery System (EHRS) → Troubleshooting” chapter in the applicable Shop Manual on KGIS. Alternatively, you may loop the coolant hose (using a spare piece of hose and coupler) to bypass the EHRS and verify if the overheating condition is resolved.
