TECHNICAL SERVICE BULLETIN

Turn Signal Flashing Fast In The IPC - Built On 01-Jan-2021 And Through 30-Apr-2021

21-2291

Ford
2021 F-150

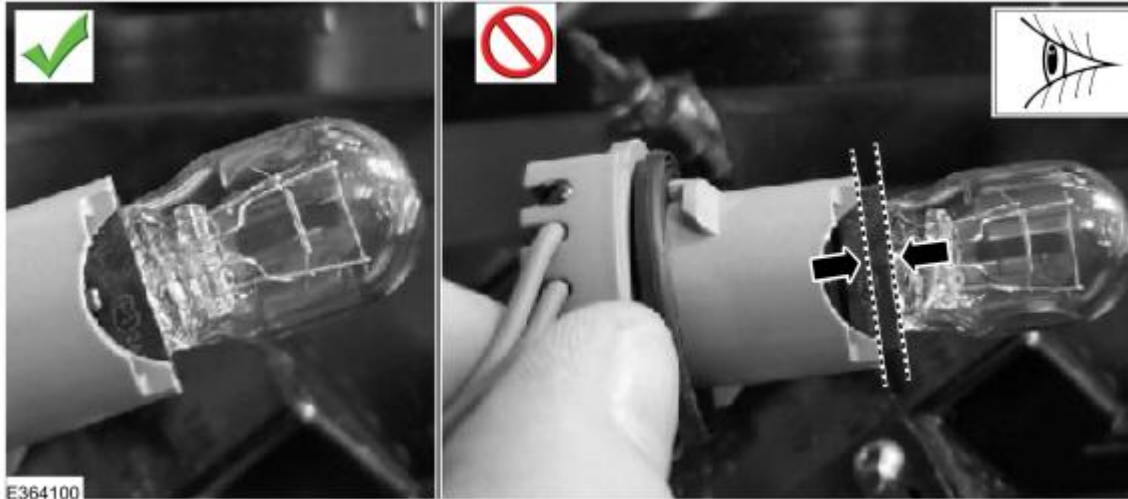
Figure 1

2. Is the rear lamp bulb completely inserted into the bulb socket? A completely inserted bulb will have the top of the bulb connector flush with the top of the bulb socket. (Figure 1)

- (1). Yes - proceed to Step 3.
 - (2). No - discard the affected bulb and obtain a replacement bulb for installation later in this procedure. Proceed to Step 4.
3. Inspect the affected rear lamp bulb filament for being burned out or open. Is the affected rear lamp bulb filament burned out or open?
 - (1). Yes - this article does not apply.
 - (2). No - proceed to Step 4.
 4. Remove the rear lamp assembly on the other side of the vehicle. Refer to WSM, Section 417-01. Proceed to Step 5.
 5. Remove and discard the rear lamp wire harness assemblies on both sides.
 - (1). Using pliers, remove the rear lamp wire harness fastener from the rear lamp housing near the upper bulb socket. The metal retainer from the rear lamp wire harness fastener may remain in the lamp housing. Needle nose pliers can be used to extract and discard the metal retainer. (Figure 2)
