# TECHNICAL SERVICE BULLETIN

## Illuminated Airbag Warning Indicator With DTC B1404:13 And/Or B1407:13

**21-2297**  
10 September  
2021

<b>Ford</b> 2021 Bronco
2020-2021 Explorer
<b>Lincoln</b> 2020-2021 Aviator

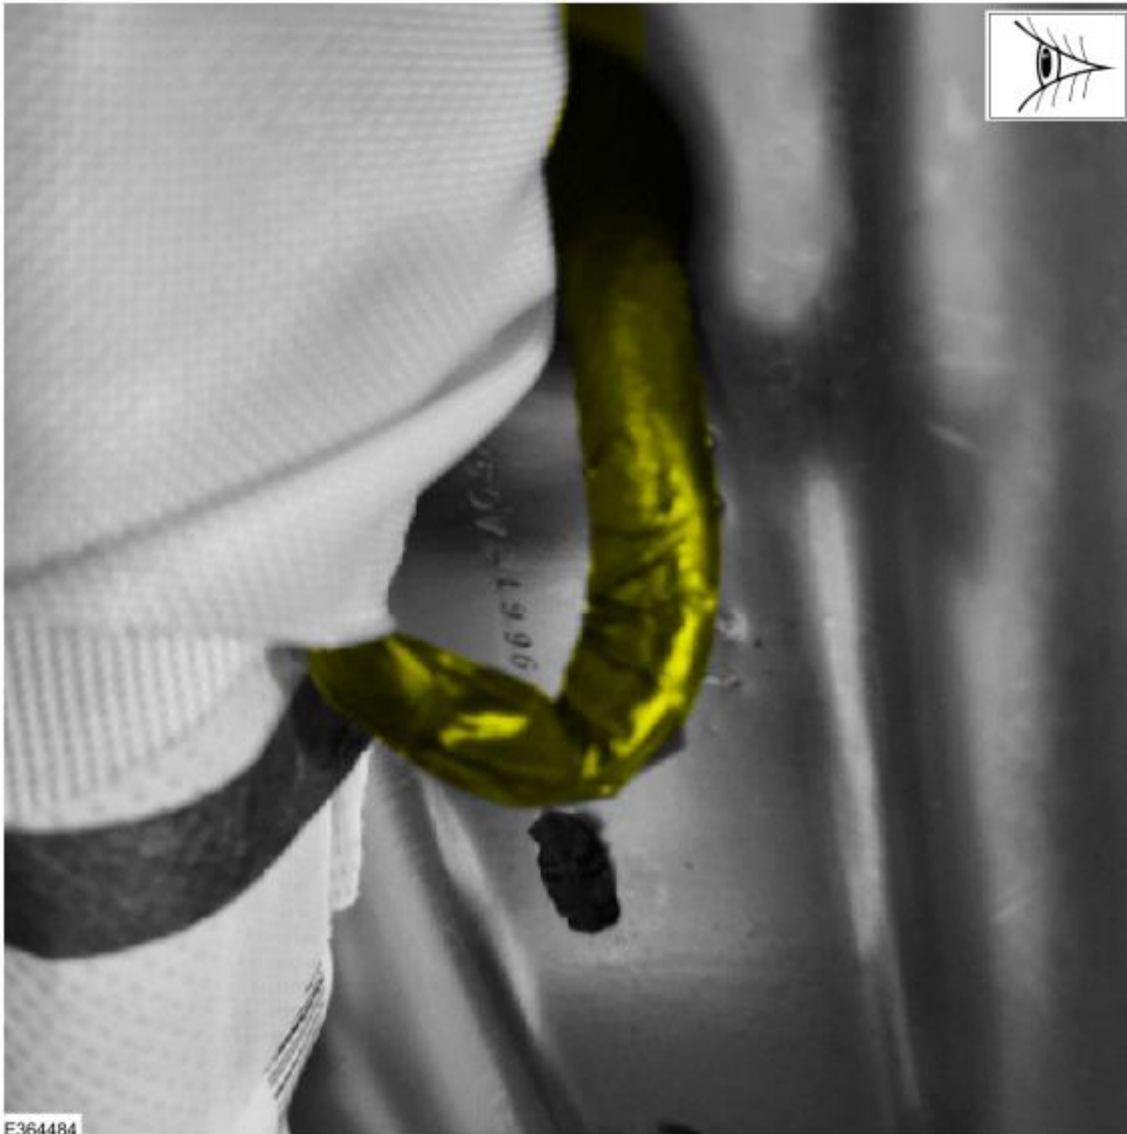
Figure 1

**Issue:** Some 2020-2021 Explorer/Aviator and 2021 Bronco vehicles may exhibit an illuminated airbag warning indicator with diagnostic trouble code (DTC) B1404:13 and/or B1407:13. This may be due to contamination and relative movement in the connection between the wiring harness and the side airbag. To correct the condition, follow the Service Procedure steps to replace the affected connector with a service pigtail and the affected side airbag.

5. Make sure the wiring harness is pulled outboard of the seat frame to prevent strain on the connector after replacing the side airbag. (Figure 1)
