# TECHNICAL SERVICE BULLETIN

## Water Leak Into Liftgate - Built On Or Before 01-Jul-2021

**21-2307**  
13 September 2021

<b>Ford</b> 2021 Mustang Mach-E
------------------------------------

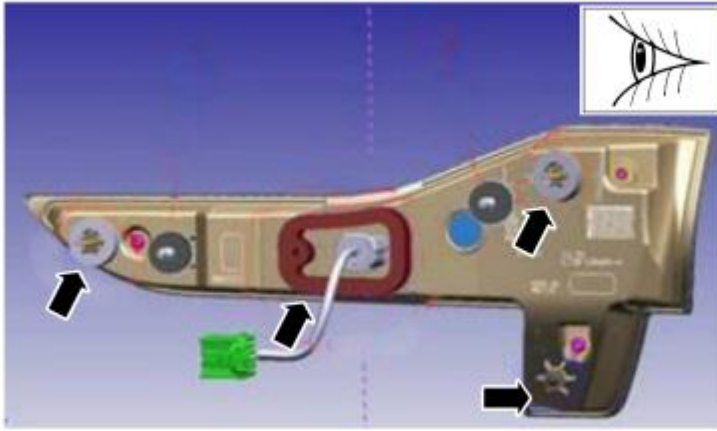
Figure 1

1. Remove the liftgate mounted rear lamp assemblies. Refer to Workshop Manual (WSM), Section 417-01 > Removal And Installation > Rear Lamp Assembly > Liftgate Mounted Rear Lamp Assemblies.
2. Determine which lamp cavity has been leaking by inspecting for water trace. (Figures 1-2)
