Service Update

SU2103 Shaw J1939 DEF Sensor Troubleshooting Guide

DIGITAL SENSOR FIELD TROUBLESHOOTING GUIDE

DOCUMENT NO: 0000297252

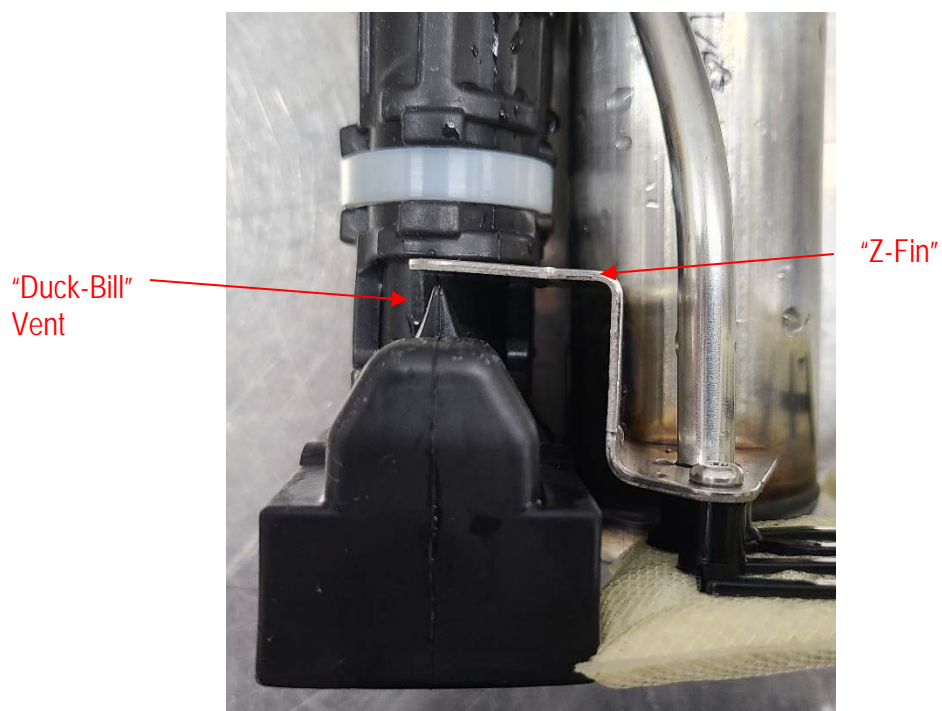
Figure 14: "Duck-Bill" Vent and "Z-Fin" Closeup

1. The DEF tank is empty or extremely low
2. The DEF tank was recently filled at a high GPM fill rate (Gen4 and Gen5 only)
3. Crystallized DEF causing the sensor shroud to seal, thereby now allowing DEF into the measurement chamber
 - i. Gen4 and Gen5 only. Typically only after equipment is removed from storage
4. The DEF tank is frozen and not thawing in the expected period of time
5. The DEF tank temperature is excessively hot ($>55^{\circ}\text{C}$)
 - i. At elevated temperatures, the solubility of air in the DEF is reduced, and dissolved air can spontaneously come out of solution and form bubbles on measurement surfaces, thereby affecting performance.

- a. Impact the side of the tank with a rubber mallet. In some cases this has been proven to cause the sensor to vent the trapped air
 - b. With the keyswitch OFF, unbolt the header from the tank, and raise it out of the fluid, allowing the sensor to drain. If the header is a Gen4 with a shroud, inspect the sensor "duck-bill" vent for interference with the "z-fin" (see Figure 14). If the header is a Gen4 with a shroud or Gen5, peel back the shroud (see Figure 15) and reseal it, and manipulate the "duck-bill" vent as shown in Figure 16 to ensure it is not sticking shut. Replace the header into the tank, turn the keyswitch ON and confirm the sensor is reading correctly (using either a Shaw Development Scan Gauge tool, or Cummins Insite).
