David J. Johnson
Director
Service Engineering Operations
Ford Customer Service Division

September 13, 2021

SUBJECT: **Customer Satisfaction Program 21N08**
Certain 2017-2020 Model Year F-150, 2018-2020 Expedition, and 2018-2020 Navigator Vehicles Equipped with a 3.5L GTDI Engine
PCM Reprogram Due to Engine Shudder

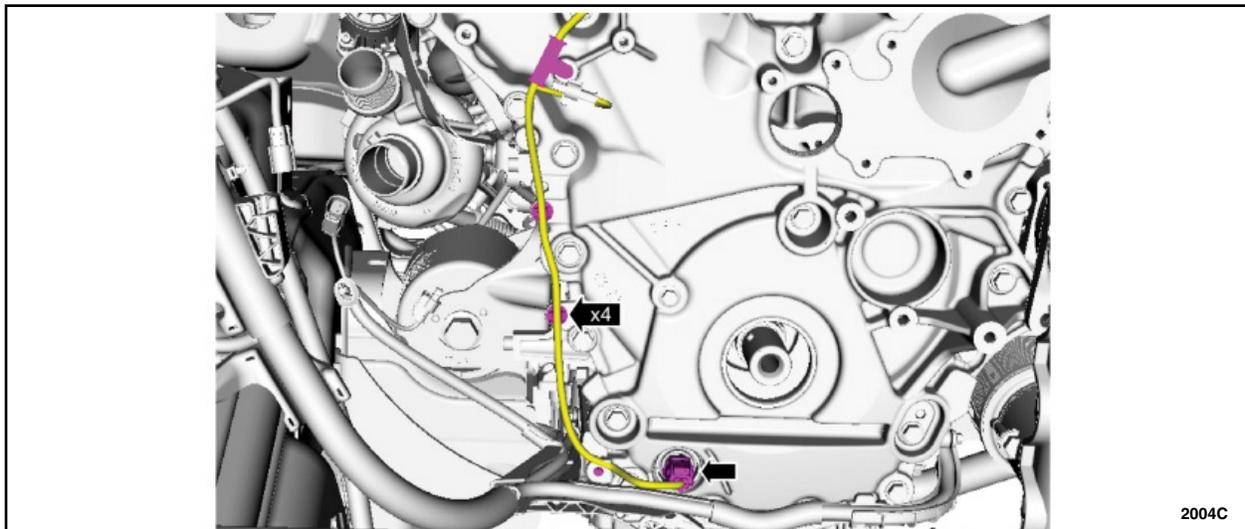
FIGURE 1

Yes – Fails inspection. Proceed to Step 4.
No – Passes inspection, this Field Service Action does not apply.
4. Disconnect the oil pump electrical connector from the engine and secure to wire harness or coolant tube with a zip tie to prevent movement. See Figure 1.
