SS 3091-FTL2021 Damaged SGA Wires at Grab Handle Located on Right A Pillar

P4 Vehicles with Side Guard Assist (SGA)

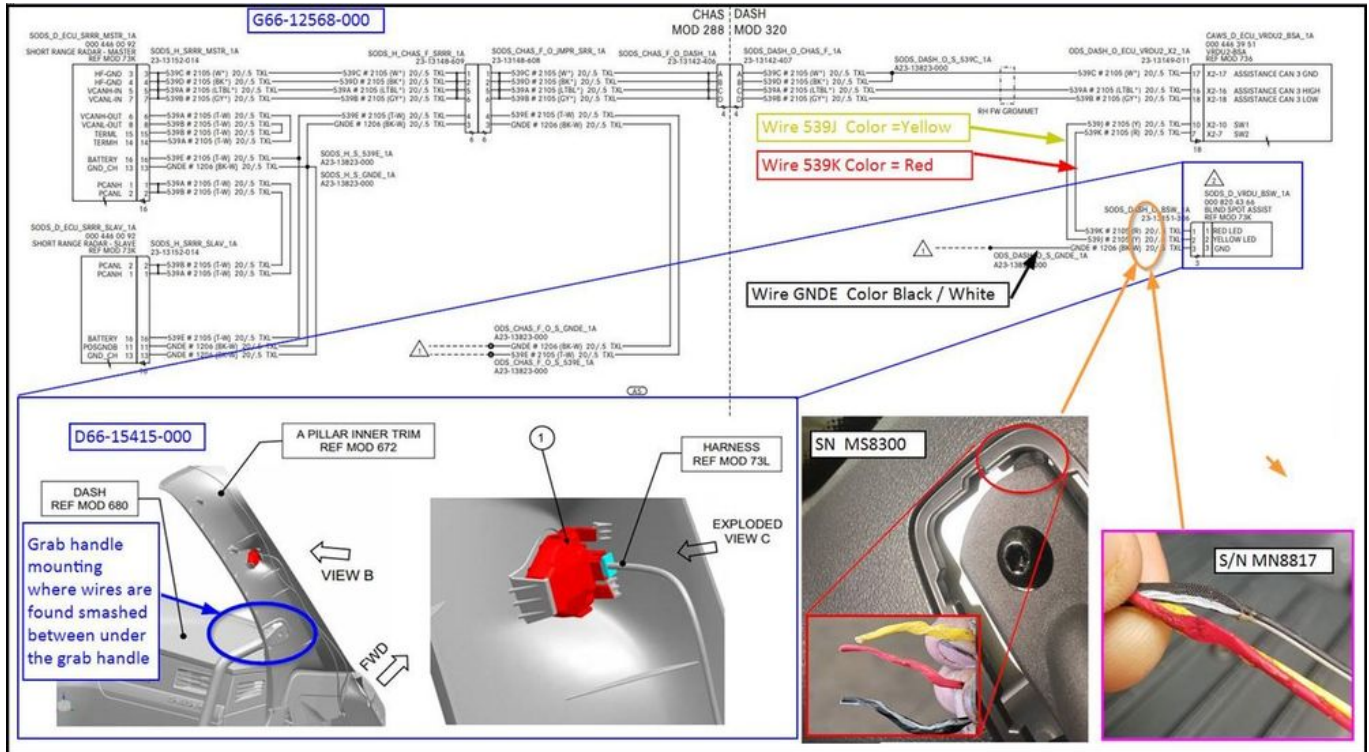
Figure 1

The field had reported failed VRDU modules related to wires damage for the SGA. Even though validation of the failed modules, as it relates to the damaged wires has not been confirmed, the intension of this service solution to bring awareness to wire routing for the SGA at the right side A

If a vehicle has a failed VRDU or multiple failed VRDUs and the fault codes listed in the symptoms above, it would be recommended to remove the right side A pillar grab handle and inspect for any damaged wired at or under the grab handle (reference Figure 1).
